**BUREAU
VERITAS**

FACILITY CONDITION ASSESSMENT

El Roble Elementary School
930 Third Street
Gilroy, CA 95020

August 30, 2025

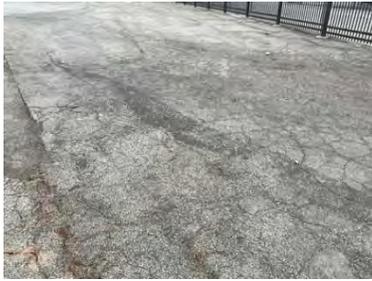
Sidewalk in Poor condition.

Asphalt
Site
Site Parking Areas

The asphalt sidewalk shows significant cracking and surface deterioration. Multiple areas are uneven. Replacement is recommended. - AssetCALC ID: 9624106

Uniformat Code: G2030
Recommendation: **Replace in 2026**

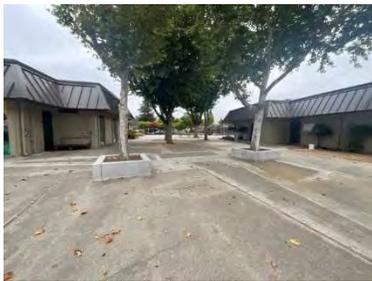
Landscaping in Poor condition.

Mature Trees, Removal or Heavy Trimming
Site

Heavy Trimming is recommended for all trees. - AssetCALC ID: 9624094

Uniformat Code: G2080
Recommendation: **Repair in 2025**
