FACILITY CONDITION ASSESSMENT

Gilroy Unified School District
7810 Arroyo Circle
Gilroy, CA 95020

Eliot Elementary School
475 Old Gilroy Street
Gilroy, CA 95020

July 29, 2025

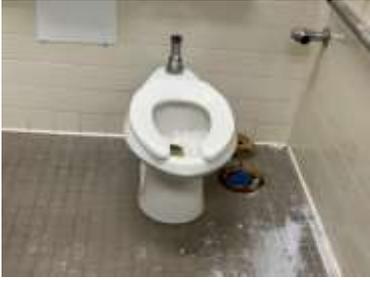
Commercial Water Closet
Kindergarten
Restrooms

Toilet in Poor condition.

It appears that Work is underway on this toilet, but currently not functioning - AssetCALC ID: 9477732

Uniformat Code: D2010
Recommendation: **Replace in 2025**

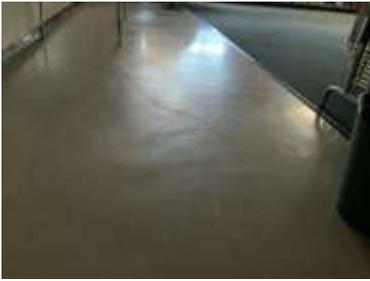
Structural, Superstructure
Multiple Use / Classrooms
C204, C209, C211

There seems to be a pattern of possible slab failure, it warrants looking into - AssetCALC ID: 9477709

Recommended Follow-up Study:

Uniformat Code: P2030
Recommendation: **Evaluate/Report in 2025**
