FACILITY CONDITION ASSESSMENT

Gilroy Unified School District

Glen View Elementary School

July 28, 2025

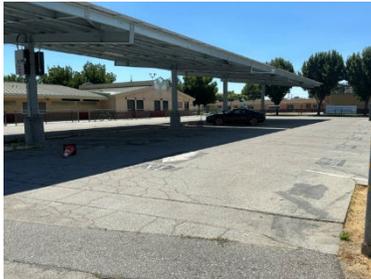
Parking Lots in Poor Condition.

Pavement, Asphalt
 Glen View Elementary School - Site
 Site Parking Areas

Parking lot has cracking, faded striping, surface wear, and uneven patching. Recommendations are to mill, overlay, seal, and re-stripe. - AssetCALC ID: 9546416

Uniformat Code: G2020
 Recommendation: **Seal & Stripe in 2026**

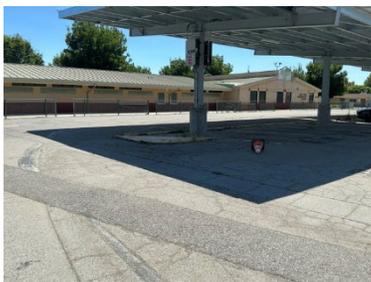
Parking Lots in Poor Condition.

Pavement, Asphalt
 Glen View Elementary School - Site
 Site Parking Areas

Parking lot has cracking, faded striping, surface wear, and uneven patching. Recommendations are to mill, overlay, seal, and re-stripe. - AssetCALC ID: 9546403

Uniformat Code: G2020
 Recommendation: **Mill & Overlay in 2026**

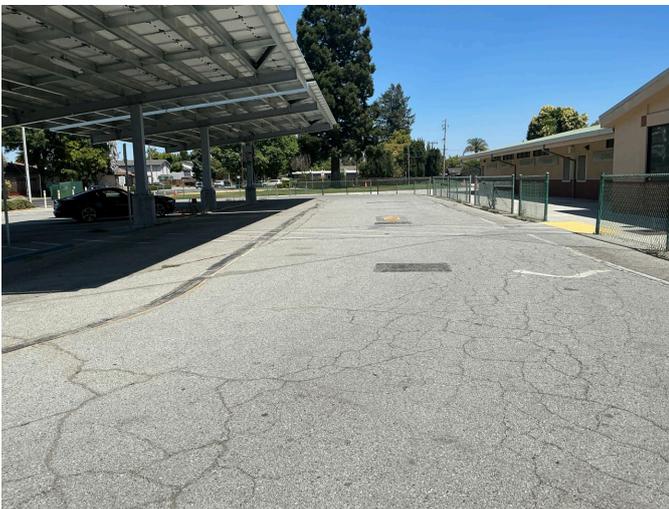
21 - PARKING LOT

The site is comprised of concrete and asphalt pavement, play surfaces, and playground area. Asphalt parking lots serve the facility on the west end of campus. The parking lot has cracking and has wear and tear which will require attention. Lighting is limited around the buildings.
