FACILITY CONDITION ASSESSMENT

Rod Kelley Elementary School

August 11, 2025

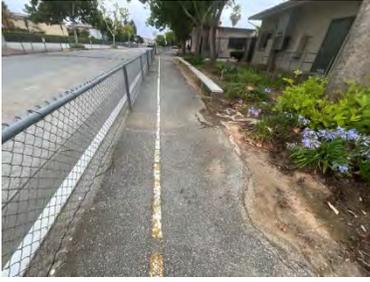
Sidewalk in Poor condition.

Sidewalk is uneven with potential tripping hazards. Repair and replacement recommended for safety. -
AssetCALC ID: 9606955

Uniformat Code: G2030
Recommendation: **Replace in 2026**
