FACILITY CONDITION ASSESSMENT

Gilroy Unified School District
7810 Arroyo Circle
Gilroy, CA 95020

Rucker Elementary School
325 Santa Clara Avenue
Gilroy, CA 95020

August 21, 2025

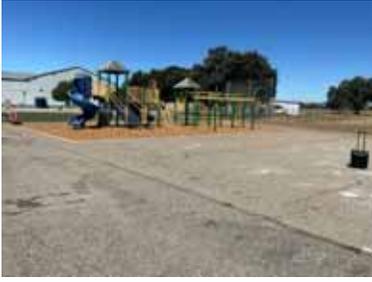
Asphalt
Site
Throughout Site

Sidewalk in Poor condition.

Uniformat Code: G2030
Recommendation: **Replace in 2026**
