# FACILITY CONDITION ASSESSMENT

**Gilroy Unified School District**  
7810 Arroyo Circle  
Gilroy, CA 95020

Gilroy Prep School  
277 loof Avenue  
Gilroy, CA 95020

*August 8, 2025*

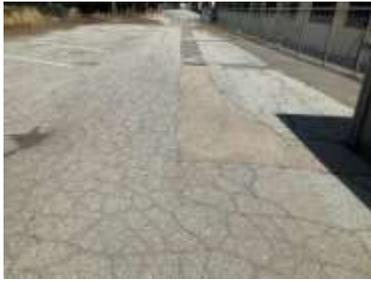
### Parking Lots in Poor condition.

Pavement, Asphalt  
 Site  
 West side of Site

Significant alligator cracking - AssetCALC ID: 9548680

Uniformat Code: G2020  
 Recommendation: **Cut & Patch in 2025**

Cost Estimate: \$45,400

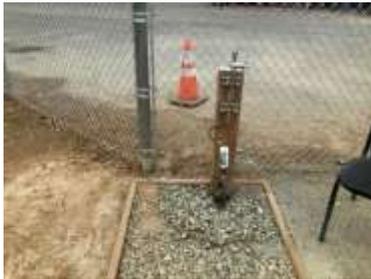
### Drinking Fountain in Poor condition.

Exterior/Site, Economy Pedestal  
 Site  
 Site Sports Fields & Courts

It leaks and it is inaccessible, according to ADA - AssetCALC ID: 9548696

Uniformat Code: D2010  
 Recommendation: **Replace in 2026**

Cost Estimate: \$800

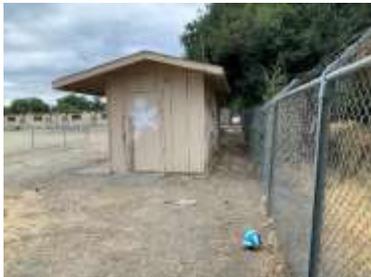
### Shed/Gazebo/Shade Structure in Poor condition.

Wood or Metal-Framed, Basic/Minimal  
 Site  
 Site Sports Fields & Courts

Locked inaccessible, condemned slated to be removed - AssetCALC ID: 9548659

Uniformat Code: F1020  
 Recommendation: **Replace in 2025**

Cost Estimate: \$3,500
