FACILITY CONDITION ASSESSMENT

Ascencion Solorsano Middle School
7121 Grenache Way
Gilroy, CA 95020

171004.25R000-009.017

August 14, 2025

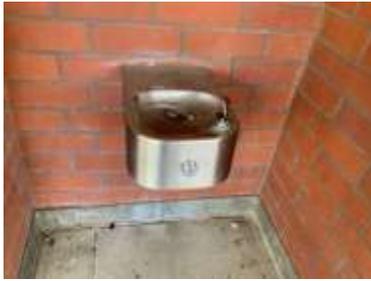
Wall-Mounted, Single-Level
C1 Classrooms
Building Exterior

Drinking Fountain in Poor condition.

The drinking fountain barely provides any water - AssetCALC ID: 9596150

Uniformat Code: D2010
Recommendation: **Replace in 2027**

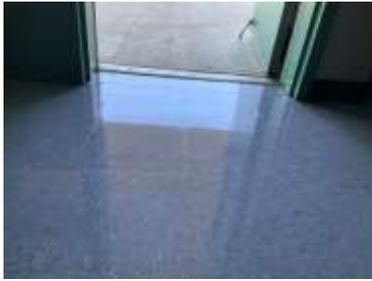
Vinyl Tile (VCT)
C3 Classrooms
C3.8

Flooring in Poor condition.

Water is coming into this classroom under the door. The exterior walkway looks to be higher than the threshold. - AssetCALC ID: 9592610

Uniformat Code: C2030
Recommendation: **Replace in 2027**

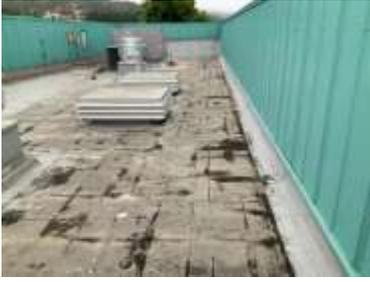
Modified Bitumen
Multi-Purpose Room
Roof

Roofing in Poor condition.

The fiberglass threads are visible in areas - AssetCALC ID: 9595413

Uniformat Code: B3010
Recommendation: **Replace in 2027**

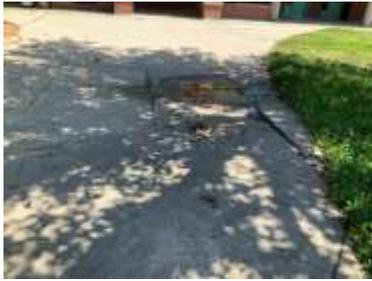
Concrete, Small Areas/Sections
Site
Site

Sidewalk in Poor condition.

The unevenness creates a hazardous situation - AssetCALC ID: 9486100

Uniformat Code: G2030
Recommendation: **Replace in 2025**

Cost Estimate: \$2,400

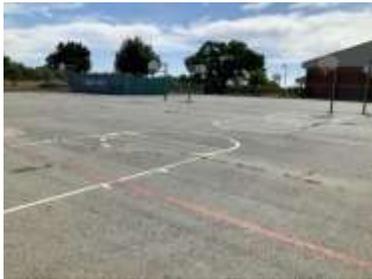
Pavement, Asphalt
Site

Playground in Poor condition.

Weeds are coming up through the cracks - AssetCALC ID: 9600248

Uniformat Code: G2010
Recommendation: **Overlay in 2027**
