# FACILITY CONDITION ASSESSMENT

**Gilroy Unified School District**  
7810 Arroyo Circle  
Gilroy, CA 95020

Christopher High School  
850 Day Road  
Gilroy, CA 95020

*Bureau Veritas*  
6021 University Boulevard, Suite 200  
Ellicott City, MD 21043  
800.733.0660  
[www.bvna.com](http://www.bvna.com)

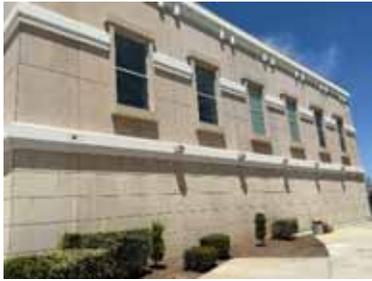
### Recommended Follow-up Study:

Building Envelope, Roof  
Christopher High School - Building E  
Roof

Roof has leaks and requires attention. - AssetCALC ID: 9590631

Uniformat Code: P2030  
Recommendation: **Evaluate/Report in 2025**

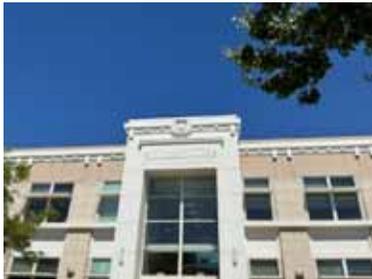
### Roofing in Poor condition.

Single-Ply Membrane, TPO/PVC  
Christopher High School - Building E  
Roof

Roof for Building E has leaks. Recommendations are to perform moisture scan to decide between coating or replacement. - AssetCALC ID: 9590661

Uniformat Code: B3010  
Recommendation: **Replace in 2027**

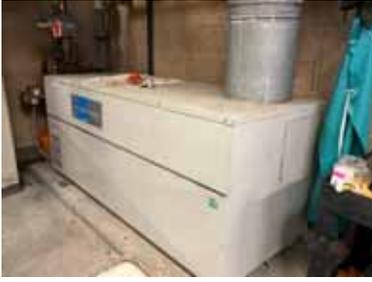
### **Pool Equipment in Poor condition.**

Gas Heater  
Christopher High School - Building H1  
Throughout

Heater is in poor condition. - AssetCALC ID: 9589407

Uniformat Code: F1050  
Recommendation: **Replace in 2027**
