FACILITY CONDITION ASSESSMENT

Gilroy Unified School District
7810 Arroyo Circle
Gilroy, CA 95020

Gilroy High School
750 West 10th Street
Gilroy, CA 95020

August 30, 2025

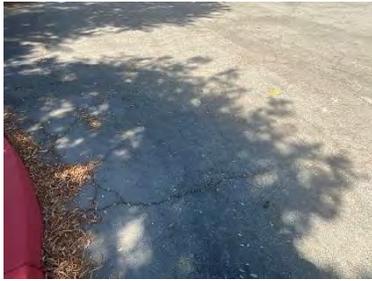
Pavement, Asphalt
Site
North side parking

Parking Lots in Poor condition.

Asphalt in parking area is deteriorated and requires repair. - AssetCALC ID: 9620425

Uniformat Code: G2020
Recommendation: **Mill & Overlay in 2026**

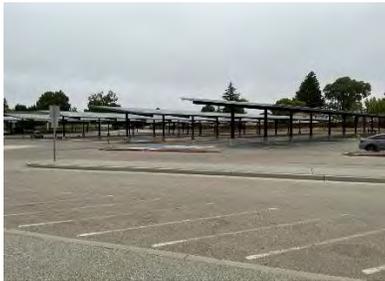
Pavement, Asphalt
Site
Site Parking Areas

Parking Lots in Poor condition.

Parking asphalt after repair requires sealing and restriping - AssetCALC ID: 9620426

Uniformat Code: G2020
Recommendation: **Seal & Stripe in 2026**
