FACILITY CONDITION ASSESSMENT

Gilroy Unified School District
7810 Arroyo Circle
Gilroy, CA 95020

171004.25R000-014.017

Mt. Madonna High School
8750 Hirasaki Court
Gilroy, CA 95020

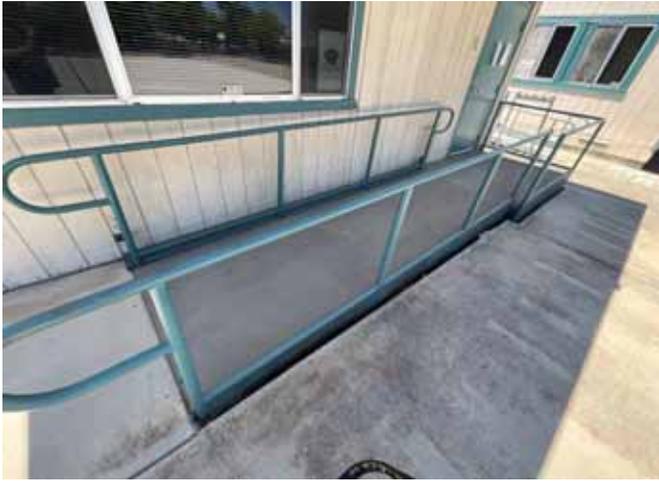
Location	UF Code	Description	Condition	Plan Type	Cost
Mt. Madonna High School / Building B	G2033	Site Stairs and Ramps, Handrails, Metal, Install	NA	Aged But Functional	\$1,000
TOTAL (1 items)					\$1,000

7 – ADA PATHS OF TRAVEL

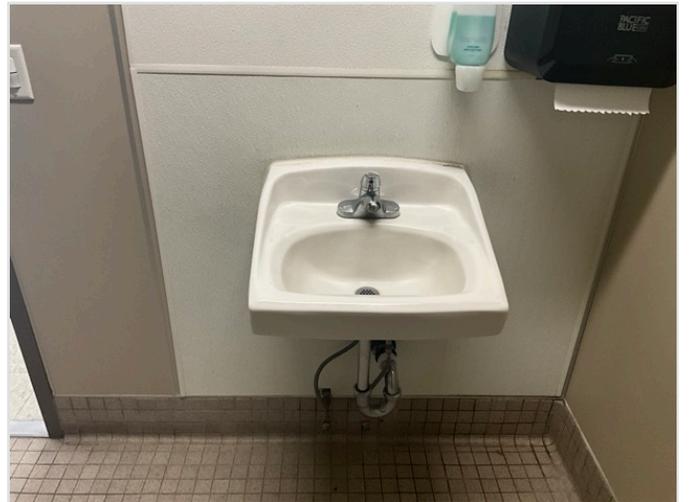
Mt. Madonna High School: Accessibility Issues				
Category	Major Issues (ADA study recommended)	Moderate Issues (ADA study recommended)	Minor Issues	None*
Parking				X
Exterior Accessible Route				X
Building Entrances				X
Interior Accessible Route				X
Elevators				
Public Restrooms			Piping is not covered below sink.	
Kitchens/Kitchenettes				
Playgrounds & Swimming Pools				
Other

FAUCET HANDLES AND PIPING
