FACILITY CONDITION ASSESSMENT

Gilroy Unified School District
7810 Arroyo Circle
Gilroy, CA 95020

Gilroy Early College Academy
5055 Santa Teresa Boulevard
Gilroy, CA 95020

171004.25R000-015.017

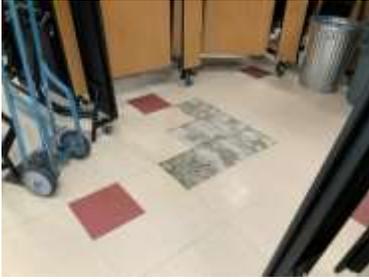
Flooring in Poor condition.

Plan Type: Safety

Vinyl Tile (VCT)
Gilroy Early College Academy
Multi-Purpose Room

Trip & health hazard - AssetCALC ID: 9544187

Uniformat Code: C2030
Recommendation: **Replace in 2025**
