FACILITY CONDITION ASSESSMENT

Gilroy Unified School District
7810 Arroyo Circle
Gilroy, CA 95020

District Office
7810 Arroyo Circle
Gilroy, CA 95020

July 29, 2025

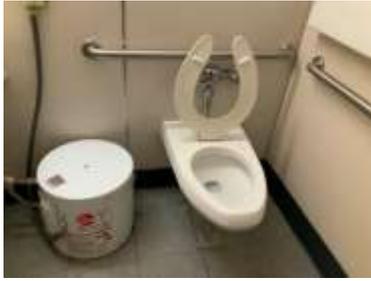
Toilet in Poor condition.

Commercial Water Closet
 District Office
 Warehouse

This is not a very safe installation - AssetCALC ID: 9482497

Uniformat Code: D2010
 Recommendation: **Replace in 2025**

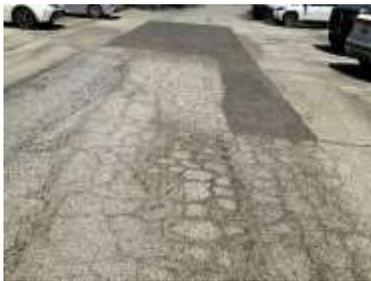
Parking Lots in Poor condition.

Pavement, Asphalt
 District Office
 Site

Serious alligator cracking, which weakens the surrounding asphalt making it worse - AssetCALC ID: 9482432

Uniformat Code: G2020
 Recommendation: **Cut & Patch in 2025**

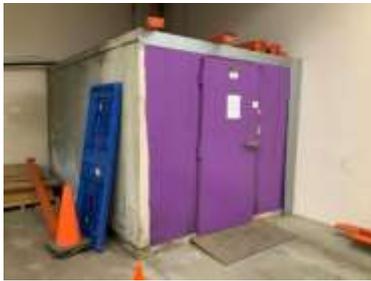
Foodservice Equipment in Failed condition.

Walk-In, Refrigerator
 District Office
 Warehouse

This has been abandoned in place - AssetCALC ID: 9482434

Uniformat Code: E1030
 Recommendation: **Replace in 2025**

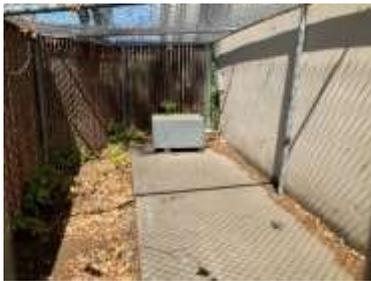
Foodservice Equipment in Poor condition.

Walk-In, Condenser for Refrigerator/Freezer
 District Office
 Building Exterior

Abandoned in place - AssetCALC ID: 9482450

Uniformat Code: E1030
 Recommendation: **Replace in 2025**

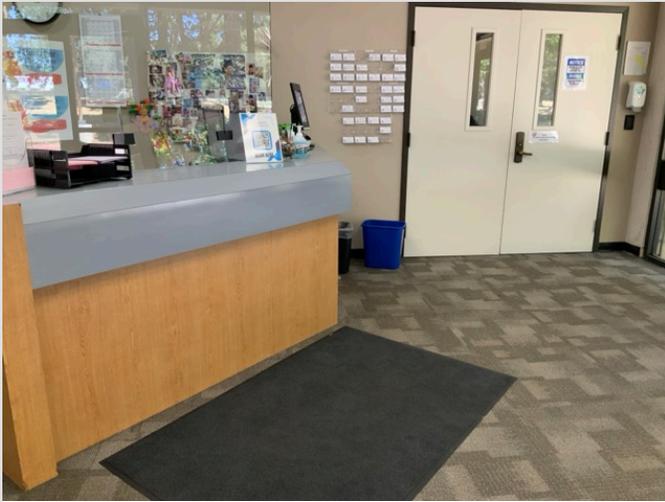
NO LOWERED COUNTER

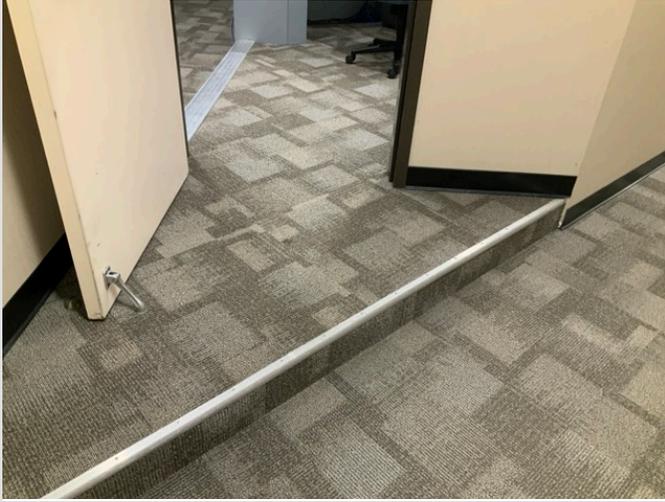
NO ACCESS TO RAISED SEATING

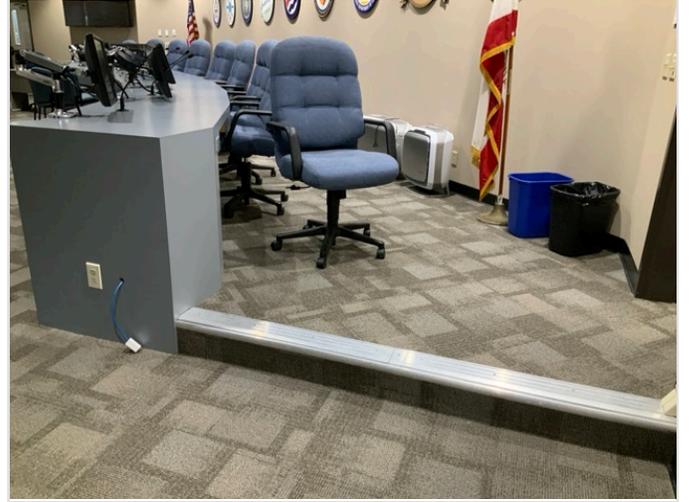
NO ACCESS TO RAISED SEATING
