**BUREAU
VERITAS**

FACILITY CONDITION ASSESSMENT

El Roble Elementary School
930 Third Street
Gilroy, CA 95020

August 30, 2025

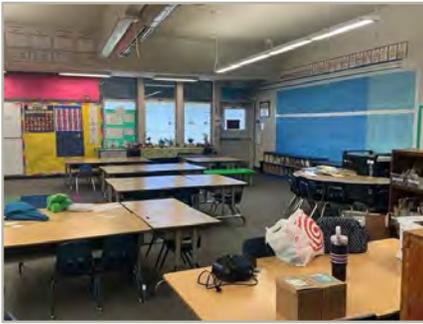
Fire Suppression System

Full System Install/Retrofit, Medium Density/Complexity
Building A
Throughout Building

The building lacks a fire suppression system and the school is likely "grandfathered" based on code at the time of original construction. A comprehensive building renovation would likely trigger full compliance to current codes, and a budgetary cost for a full fire suppression retrofit is included in the initial five-year plan. - AssetCALC ID: 9648012

Uniformat Code: D4010
Recommendation: **Renovate in 2029**

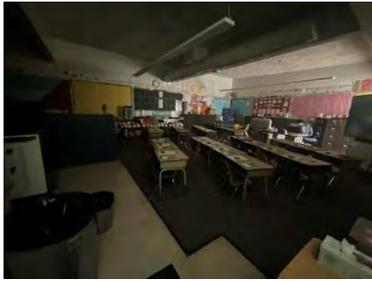
Fire Suppression System

Full System Install/Retrofit, Medium Density/Complexity
Building B
Throughout Building

The building lacks a fire suppression system and the school is likely "grandfathered" based on code at the time of original construction. A comprehensive building renovation would likely trigger full compliance to current codes, and a budgetary cost for a full fire suppression retrofit is included in the initial five-year plan. - AssetCALC ID: 9684131

Uniformat Code: D4010
Recommendation: **Renovate in 2029**

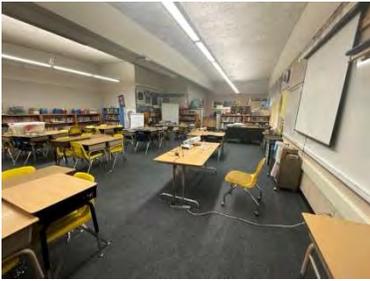
Fire Suppression System

Full System Install/Retrofit, Medium Density/Complexity
Building C
Throughout Building

The building lacks a fire suppression system and the school is likely "grandfathered" based on code at the time of original construction. A comprehensive building renovation would likely trigger full compliance to current codes, and a budgetary cost for a full fire suppression retrofit is included in the initial five-year plan. - AssetCALC ID: 9684163

Uniformat Code: D4010
Recommendation: **Renovate in 2029**

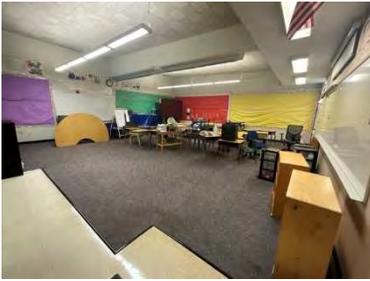
Fire Suppression System

Full System Install/Retrofit, Medium Density/Complexity
Building D
Throughout Building

The building lacks a fire suppression system and the school is likely "grandfathered" based on code at the time of original construction. A comprehensive building renovation would likely trigger full compliance to current codes, and a budgetary cost for a full fire suppression retrofit is included in the initial five-year plan. - AssetCALC ID: 9684195

Uniformat Code: D4010
Recommendation: **Renovate in 2029**

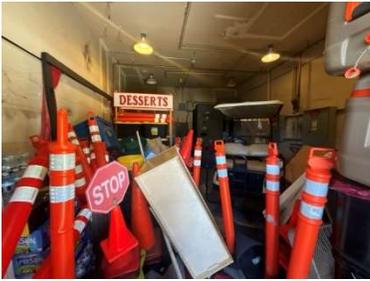
Fire Suppression System

Full System Install/Retrofit, Medium Density/Complexity
Building G
Throughout Building

The building lacks a fire suppression system and the school is likely "grandfathered" based on code at the time of original construction. A comprehensive building renovation would likely trigger full compliance to current codes, and a budgetary cost for a full fire suppression retrofit is included in the initial five-year plan. - AssetCALC ID: 9683597

Uniformat Code: D4010
Recommendation: **Renovate in 2029**

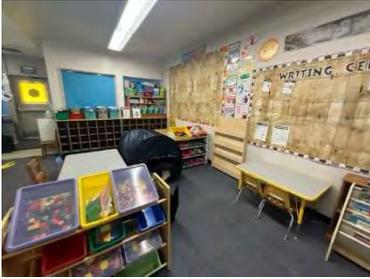
Fire Suppression System

Full System Install/Retrofit, Medium Density/Complexity
Building K
Throughout Building

The building lacks a fire suppression system and the school is likely "grandfathered" based on code at the time of original construction. A comprehensive building renovation would likely trigger full compliance to current codes, and a budgetary cost for a full fire suppression retrofit is included in the initial five-year plan. - AssetCALC ID: 9648197

Uniformat Code: D4010
Recommendation: **Renovate in 2029**

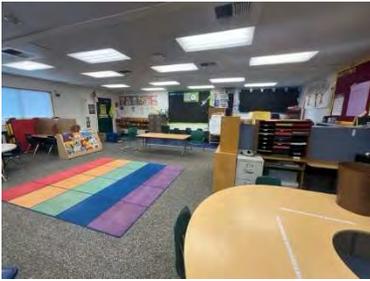
Fire Suppression System

Full System Install/Retrofit, Medium Density/Complexity
P 21
Throughout Building

The building lacks a fire suppression system and the school is likely "grandfathered" based on code at the time of original construction. A comprehensive building renovation would likely trigger full compliance to current codes, and a budgetary cost for a full fire suppression retrofit is included in the initial five-year plan. - AssetCALC ID: 9684425

Uniformat Code: D4010
Recommendation: **Renovate in 2029**

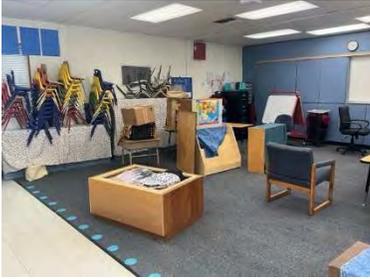
Fire Suppression System

Full System Install/Retrofit, Medium Density/Complexity
P 22
Throughout Building

The building lacks a fire suppression system and the school is likely "grandfathered" based on code at the time of original construction. A comprehensive building renovation would likely trigger full compliance to current codes, and a budgetary cost for a full fire suppression retrofit is included in the initial five-year plan. - AssetCALC ID: 9684585

Uniformat Code: D4010
Recommendation: **Renovate in 2029**

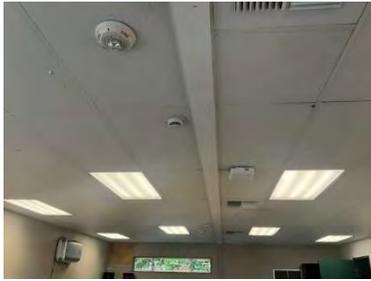
Fire Suppression System

Full System Install/Retrofit, Medium Density/Complexity
P 23 & 24
Throughout Building

The building lacks a fire suppression system and the school is likely "grandfathered" based on code at the time of original construction. A comprehensive building renovation would likely trigger full compliance to current codes, and a budgetary cost for a full fire suppression retrofit is included in the initial five-year plan. - AssetCALC ID: 9686715

Uniformat Code: D4010
Recommendation: **Renovate in 2029**

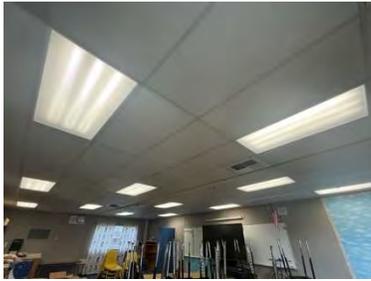
Fire Suppression System

Full System Install/Retrofit, Medium Density/Complexity
P25
Throughout Building

The building lacks a fire suppression system and the school is likely "grandfathered" based on code at the time of original construction. A comprehensive building renovation would likely trigger full compliance to current codes, and a budgetary cost for a full fire suppression retrofit is included in the initial five-year plan. - AssetCALC ID: 9684607

Uniformat Code: D4010
Recommendation: **Renovate in 2029**

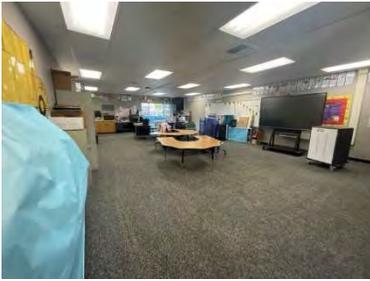
Fire Suppression System

Full System Install/Retrofit, Medium Density/Complexity
P26
Throughout Building

The building lacks a fire suppression system and the school is likely "grandfathered" based on code at the time of original construction. A comprehensive building renovation would likely trigger full compliance to current codes, and a budgetary cost for a full fire suppression retrofit is included in the initial five-year plan. - AssetCALC ID: 9684628

Uniformat Code: D4010
Recommendation: **Renovate in 2029**

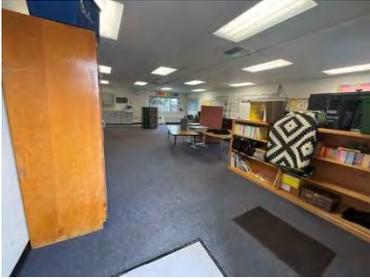
Fire Suppression System

Full System Install/Retrofit, Medium Density/Complexity
P27
Throughout Building

The building lacks a fire suppression system and the school is likely "grandfathered" based on code at the time of original construction. A comprehensive building renovation would likely trigger full compliance to current codes, and a budgetary cost for a full fire suppression retrofit is included in the initial five-year plan. - AssetCALC ID: 9685416

Uniformat Code: D4010
Recommendation: **Renovate in 2029**

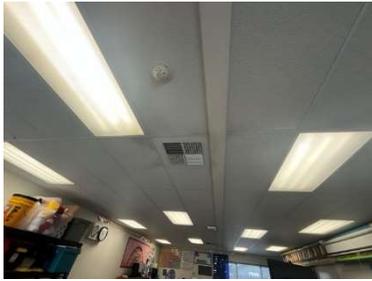
Fire Suppression System

Full System Install/Retrofit, Medium Density/Complexity
P28
Throughout Building

The building lacks a fire suppression system and the school is likely "grandfathered" based on code at the time of original construction. A comprehensive building renovation would likely trigger full compliance to current codes, and a budgetary cost for a full fire suppression retrofit is included in the initial five-year plan. - AssetCALC ID: 9685436

Uniformat Code: D4010
Recommendation: **Renovate in 2029**

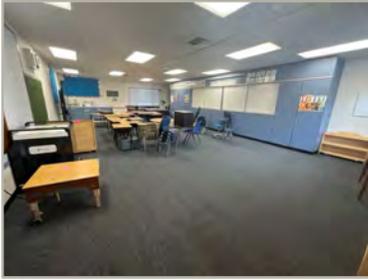
Fire Suppression System

Full System Install/Retrofit, Medium Density/Complexity
P29
Throughout Building

The building lacks a fire suppression system and the school is likely "grandfathered" based on code at the time of original construction. A comprehensive building renovation would likely trigger full compliance to current codes, and a budgetary cost for a full fire suppression retrofit is included in the initial five-year plan. - AssetCALC ID: 9685456

Uniformat Code: D4010
Recommendation: **Renovate in 2029**
