FACILITY CONDITION ASSESSMENT

Rod Kelley Elementary School

August 11, 2025

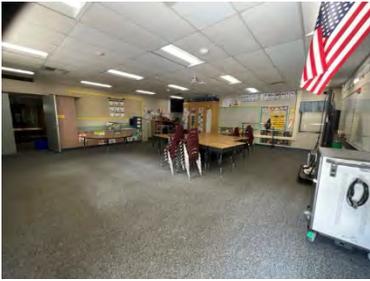
Fire Suppression System

Full System Install/Retrofit, Low
Density/Complexity
Building A
Throughout Building

The building lacks a fire suppression system, and the school is likely "grandfathered" based on code at the time of original construction. A comprehensive building renovation would likely trigger full compliance to current codes, and a budgetary cost for a full fire suppression retrofit is included in the initial five-year plan. -
AssetCALC ID: 9593709

Uniformat Code: D4010
Recommendation: **Renovate in 2030**

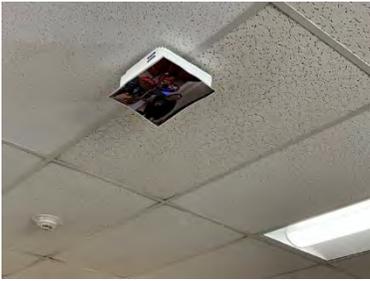
Fire Suppression System

Full System Install/Retrofit, Medium Density/Complexity
Building B
Throughout Building

The building lacks a fire suppression system and the school is likely "grandfathered" based on code at the time of original construction. A comprehensive building renovation would likely trigger full compliance to current codes, and a budgetary cost for a full fire suppression retrofit is included in the initial five-year plan. - AssetCALC ID: 9594167

Uniformat Code: D4010
Recommendation: **Renovate in 2030**

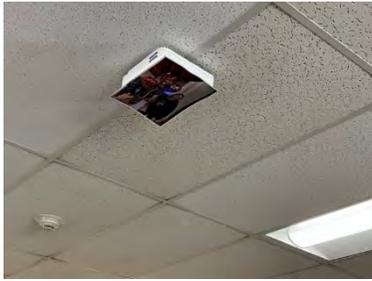
Fire Suppression System

Full System Install/Retrofit, Medium Density/Complexity
Building C
Throughout Building

The building lacks a fire suppression system and the school is likely "grandfathered" based on code at the time of original construction. A comprehensive building renovation would likely trigger full compliance to current codes, and a budgetary cost for a full fire suppression retrofit is included in the initial five-year plan. - AssetCALC ID: 9594202

Uniformat Code: D4010
Recommendation: **Renovate in 2029**

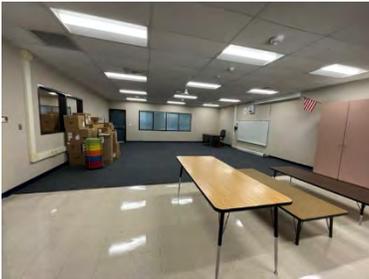
Fire Suppression System

Full System Install/Retrofit, Low
Density/Complexity
Building D
Throughout Building

The building lacks a fire suppression system and the school is likely "grandfathered" based on code at the time of original construction. A comprehensive building renovation would likely trigger full compliance to current codes, and a budgetary cost for a full fire suppression retrofit is included in the initial five-year plan. - AssetCALC ID: 9600450

Uniformat Code: D4010
Recommendation: **Install in 2030**

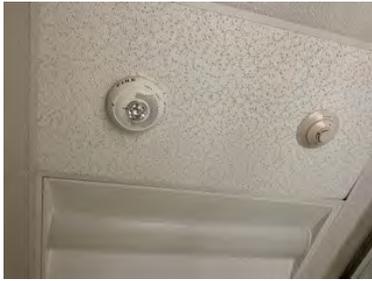
Fire Suppression System

Full System Install/Retrofit, Medium Density/Complexity
Building F
Throughout Building

The building lacks a fire suppression system and the school is likely "grandfathered" based on code at the time of original construction. A comprehensive building renovation would likely trigger full compliance to current codes, and a budgetary cost for a full fire suppression retrofit is included in the initial five-year plan. - AssetCALC ID: 9601403

Uniformat Code: D4010
Recommendation: **Renovate in 2030**

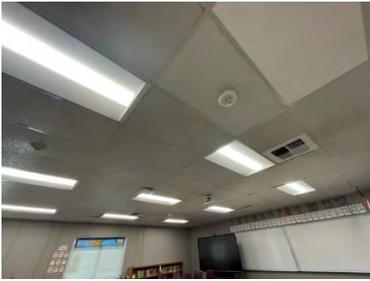
Fire Suppression System

Full System Install/Retrofit, Medium Density/Complexity
Building H
Throughout Building

Uniformat Code: D4010
Recommendation: **Renovate in 2030**

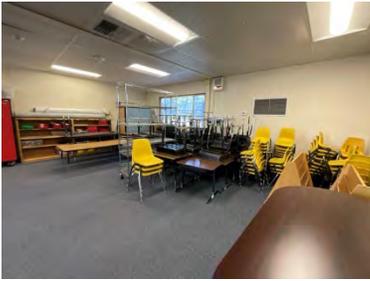
Fire Suppression System

Full System Install/Retrofit, Medium Density/Complexity
Portable 1
Throughout Building

The building lacks a fire suppression system and the school is likely "grandfathered" based on code at the time of original construction. A comprehensive building renovation would likely trigger full compliance to current codes, and a budgetary cost for a full fire suppression retrofit is included in the initial five-year plan. - AssetCALC ID: 9597337

Uniformat Code: D4010
Recommendation: **Renovate in 2030**

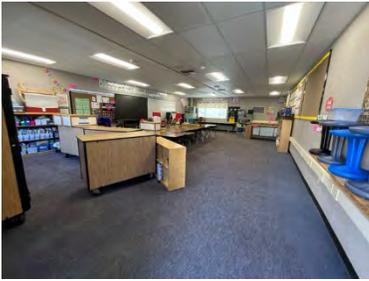
Fire Suppression System

Full System Install/Retrofit, Medium Density/Complexity
Portable 2
Throughout Building

The building lacks a fire suppression system and the school is likely "grandfathered" based on code at the time of original construction. A comprehensive building renovation would likely trigger full compliance to current codes, and a budgetary cost for a full fire suppression retrofit is included in the initial five-year plan. - AssetCALC ID: 9602795

Uniformat Code: D4010
Recommendation: **Renovate in 2030**

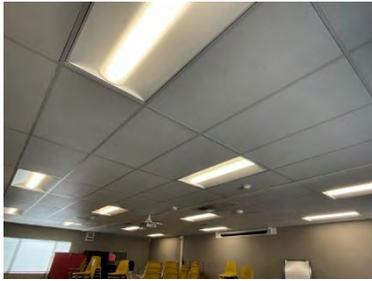
Fire Suppression System

Full System Install/Retrofit, Medium Density/Complexity
Portable 3
Throughout Building

The building lacks a fire suppression system and the school is likely "grandfathered" based on code at the time of original construction. A comprehensive building renovation would likely trigger full compliance to current codes, and a budgetary cost for a full fire suppression retrofit is included in the initial five-year plan. - AssetCALC ID: 9597378

Uniformat Code: D4010
Recommendation: **Renovate in 2030**

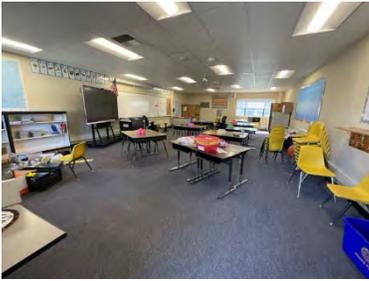
Fire Suppression System

Full System Install/Retrofit, Medium Density/Complexity
Portable 4
Throughout Building

Uniformat Code: D4010
Recommendation: **Renovate in 2030**

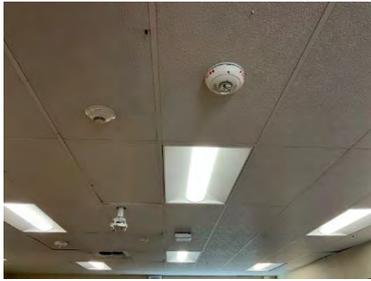
Fire Suppression System

Full System Install/Retrofit, Medium Density/Complexity
Portable 5
Throughout Building

The building lacks a fire suppression system and the school is likely "grandfathered" based on code at the time of original construction. A comprehensive building renovation would likely trigger full compliance to current codes, and a budgetary cost for a full fire suppression retrofit is included in the initial five-year plan. - AssetCALC ID: 9597439

Uniformat Code: D4010
Recommendation: **Install in 2030**

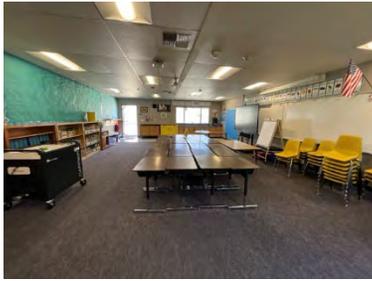
Fire Suppression System

Full System Install/Retrofit, Medium
 Density/Complexity
 Portable 7
 Throughout Building

The building lacks a fire suppression system and the school is likely "grandfathered" based on code at the time of original construction. A comprehensive building renovation would likely trigger full compliance to current codes, and a budgetary cost for a full fire suppression retrofit is included in the initial five-year plan. - AssetCALC ID: 9598763

Uniformat Code: D4010
 Recommendation: **Install in 2030**

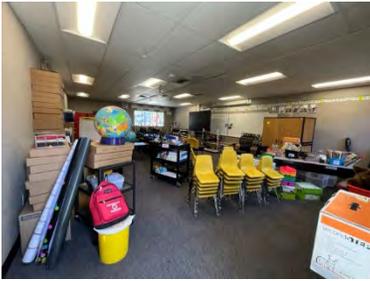
Fire Suppression System

Full System Install/Retrofit, Medium Density/Complexity
 Portable 8
 Throughout Building

The building lacks a fire suppression system and the school is likely "grandfathered" based on code at the time of original construction. A comprehensive building renovation would likely trigger full compliance to current codes, and a budgetary cost for a full fire suppression retrofit is included in the initial five-year plan. - AssetCALC ID: 9598755

Uniformat Code: D4010
 Recommendation: **Install in 2030**

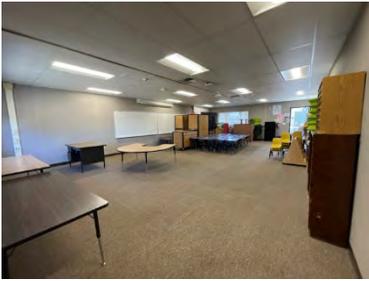
Fire Suppression System

Full System Install/Retrofit, Medium Density/Complexity
Portable 9
Throughout Building

The building lacks a fire suppression system and the school is likely "grandfathered" based on code at the time of original construction. A comprehensive building renovation would likely trigger full compliance to current codes, and a budgetary cost for a full fire suppression retrofit is included in the initial five-year plan. - AssetCALC ID: 9605031

Uniformat Code: D4010
Recommendation: **Renovate in 2030**

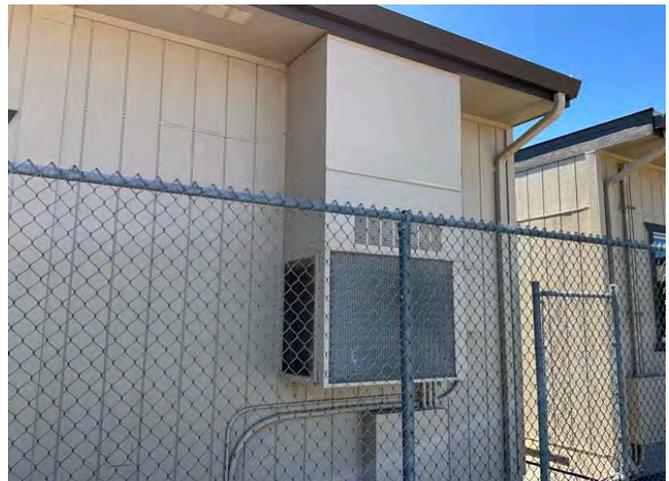
6 – HEAT PUMP

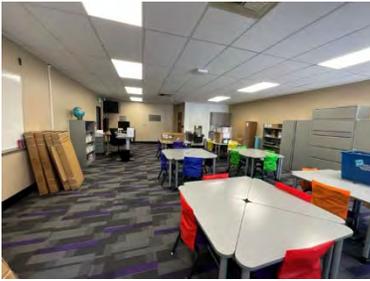
Fire Suppression System

Full System Install/Retrofit, Medium Density/Complexity
Portable 10
Throughout Building

The building lacks a fire suppression system and the school is likely "grandfathered" based on code at the time of original construction. A comprehensive building renovation would likely trigger full compliance to current codes, and a budgetary cost for a full fire suppression retrofit is included in the initial five-year plan. - AssetCALC ID: 9598717

Uniformat Code: D4010
Recommendation: **Renovate in 2030**

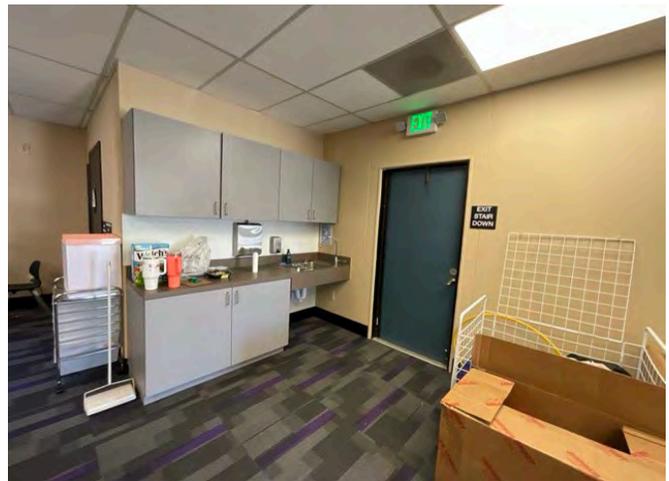
6 – KITCHENETTE

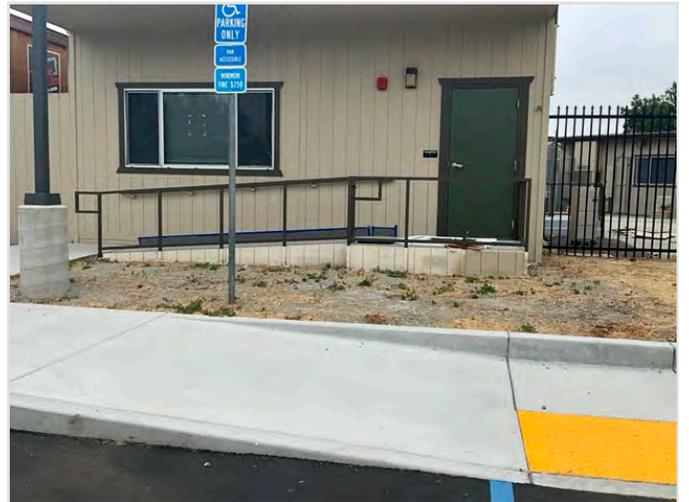
ACCESSIBLE RAMP
