FACILITY CONDITION ASSESSMENT

Gilroy Unified School District
7810 Arroyo Circle
Gilroy, CA 95020

Rucker Elementary School
325 Santa Clara Avenue
Gilroy, CA 95020

August 21, 2025

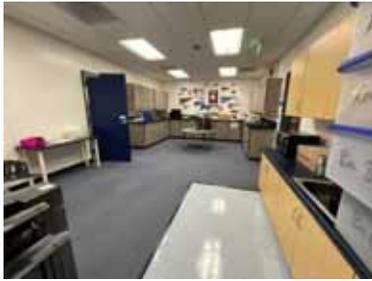
Fire Suppression System

Full System Install/Retrofit, Medium Density/Complexity
Building 100
Throughout Building

The building lacks a fire suppression system and the school is likely "grandfathered" based on code at the time of original construction. A comprehensive building renovation would likely trigger full compliance to current codes, and a budgetary cost for a full fire suppression retrofit is included in the initial five-year plan. - AssetCALC ID: 9629438

Uniformat Code: D4010
Recommendation: **Renovate in 2029**

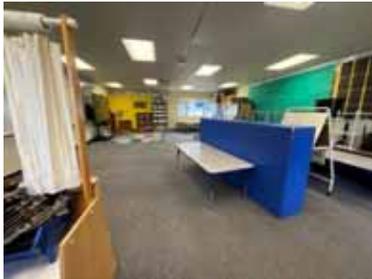
Fire Suppression System

Full System Install/Retrofit, Medium Density/Complexity
Building 110
Throughout Building

The building lacks a fire suppression system and the school is likely "grandfathered" based on code at the time of original construction. A comprehensive building renovation would likely trigger full compliance to current codes, and a budgetary cost for a full fire suppression retrofit is included in the initial five-year plan. - AssetCALC ID: 9627186

Uniformat Code: D4010
Recommendation: **Renovate in 2029**

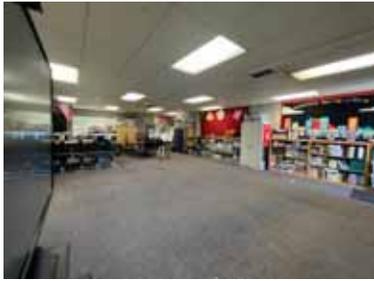
Fire Suppression System

Full System Install/Retrofit, Medium Density/Complexity
Building 130
Throughout Building

The building lacks a fire suppression system and the school is likely "grandfathered" based on code at the time of original construction. A comprehensive building renovation would likely trigger full compliance to current codes, and a budgetary cost for a full fire suppression retrofit is included in the initial five-year plan. - AssetCALC ID: 9627232

Uniformat Code: D4010
Recommendation: **Renovate in 2029**

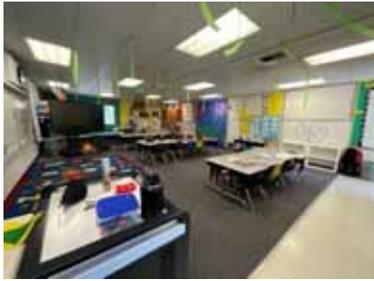
Fire Suppression System

Full System Install/Retrofit, Medium Density/Complexity
Building 140
Throughout Building

The building lacks a fire suppression system and the school is likely "grandfathered" based on code at the time of original construction. A comprehensive building renovation would likely trigger full compliance to current codes, and a budgetary cost for a full fire suppression retrofit is included in the initial five-year plan. - AssetCALC ID: 9627252

Uniformat Code: D4010
Recommendation: **Renovate in 2029**

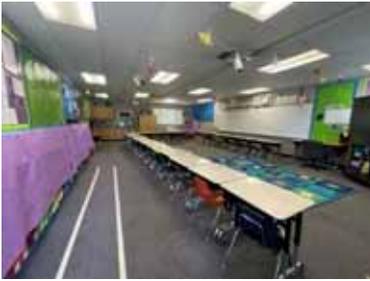
Fire Suppression System

Full System Install/Retrofit, Medium Density/Complexity
Building 150
Throughout Building

The building lacks a fire suppression system and the school is likely "grandfathered" based on code at the time of original construction. A comprehensive building renovation would likely trigger full compliance to current codes, and a budgetary cost for a full fire suppression retrofit is included in the initial five-year plan. - AssetCALC ID: 9627274

Uniformat Code: D4010
Recommendation: **Renovate in 2029**

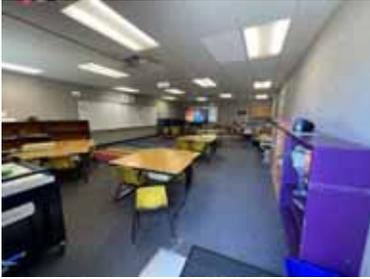
Fire Suppression System

Full System Install/Retrofit, Medium
Density/Complexity
Building 160
Throughout Building

The building lacks a fire suppression system and the school is likely "grandfathered" based on code at the time of original construction. A comprehensive building renovation would likely trigger full compliance to current codes, and a budgetary cost for a full fire suppression retrofit is included in the initial five-year plan. -
AssetCALC ID: 9627290

Uniformat Code: D4010
Recommendation: **Renovate in 2029**

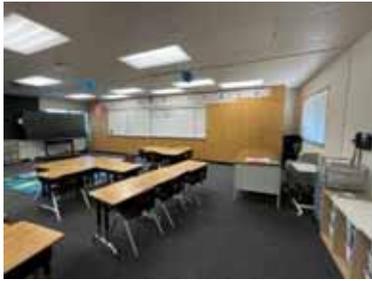
Fire Suppression System

Full System Install/Retrofit, Medium Density/Complexity
Building 170
Throughout Building

The building lacks a fire suppression system and the school is likely "grandfathered" based on code at the time of original construction. A comprehensive building renovation would likely trigger full compliance to current codes, and a budgetary cost for a full fire suppression retrofit is included in the initial five-year plan. - AssetCALC ID: 9627310

Uniformat Code: D4010
Recommendation: **Renovate in 2029**

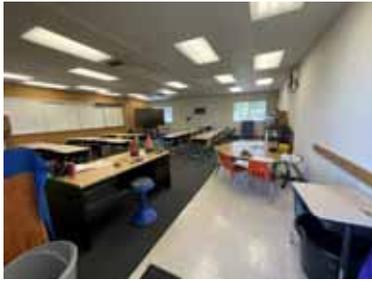
Fire Suppression System

Full System Install/Retrofit, Medium Density/Complexity
Building 180
Throughout Building

The building lacks a fire suppression system and the school is likely "grandfathered" based on code at the time of original construction. A comprehensive building renovation would likely trigger full compliance to current codes, and a budgetary cost for a full fire suppression retrofit is included in the initial five-year plan. - AssetCALC ID: 9627452

Uniformat Code: D4010
Recommendation: **Renovate in 2029**

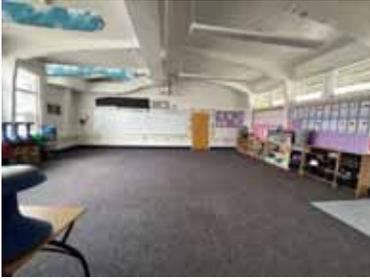
Fire Suppression System

Full System Install/Retrofit, Medium Density/Complexity
Building 200
Throughout Building

The building lacks a fire suppression system and the school is likely "grandfathered" based on code at the time of original construction. A comprehensive building renovation would likely trigger full compliance to current codes, and a budgetary cost for a full fire suppression retrofit is included in the initial five-year plan. - AssetCALC ID: 9584883

Uniformat Code: D4010
Recommendation: **Renovate in 2029**

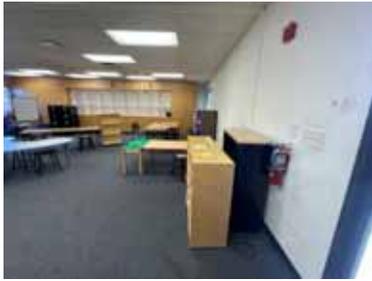
Fire Suppression System

Full System Install/Retrofit, Medium
Density/Complexity
Building 210
Throughout Building

The building lacks a fire suppression system and the school is likely "grandfathered" based on code at the time of original construction. A comprehensive building renovation would likely trigger full compliance to current codes, and a budgetary cost for a full fire suppression retrofit is included in the initial five-year plan. -
AssetCALC ID: 9627468

Uniformat Code: D4010
Recommendation: **Renovate in 2029**

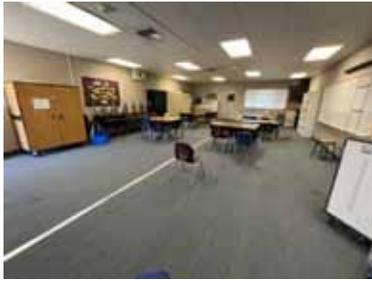
Fire Suppression System

Full System Install/Retrofit, Medium Density/Complexity
Building 240
Throughout Building

The building lacks a fire suppression system and the school is likely "grandfathered" based on code at the time of original construction. A comprehensive building renovation would likely trigger full compliance to current codes, and a budgetary cost for a full fire suppression retrofit is included in the initial five-year plan. - AssetCALC ID: 9627486

Uniformat Code: D4010
Recommendation: **Renovate in 2029**

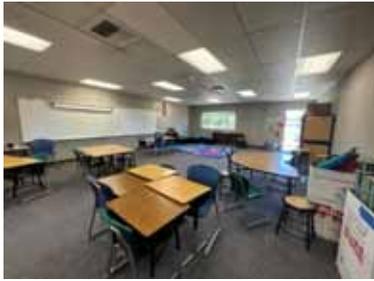
Fire Suppression System

Full System Install/Retrofit, Medium Density/Complexity
Building 250
Throughout Building

The building lacks a fire suppression system and the school is likely "grandfathered" based on code at the time of original construction. A comprehensive building renovation would likely trigger full compliance to current codes, and a budgetary cost for a full fire suppression retrofit is included in the initial five-year plan. - AssetCALC ID: 9627531

Uniformat Code: D4010
Recommendation: **Renovate in 2029**

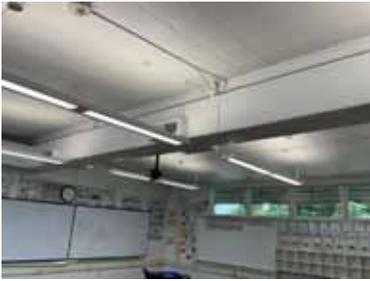
Fire Suppression System

Full System Install/Retrofit, Medium Density/Complexity
Building 300
Throughout Building

The building lacks a fire suppression system and the school is likely "grandfathered" based on code at the time of original construction. A comprehensive building renovation would likely trigger full compliance to current codes, and a budgetary cost for a full fire suppression retrofit is included in the initial five-year plan. - AssetCALC ID: 9588323

Uniformat Code: D4010
Recommendation: **Renovate in 2029**

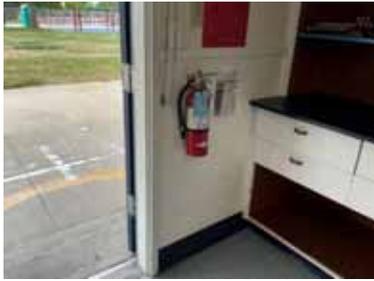
Fire Suppression System

Full System Install/Retrofit, Medium Density/Complexity
Building 400
Throughout Building

The building lacks a fire suppression system and the school is likely "grandfathered" based on code at the time of original construction. A comprehensive building renovation would likely trigger full compliance to current codes, and a budgetary cost for a full fire suppression retrofit is included in the initial five-year plan. - AssetCALC ID: 9588347

Uniformat Code: D4010
Recommendation: **Renovate in 2029**

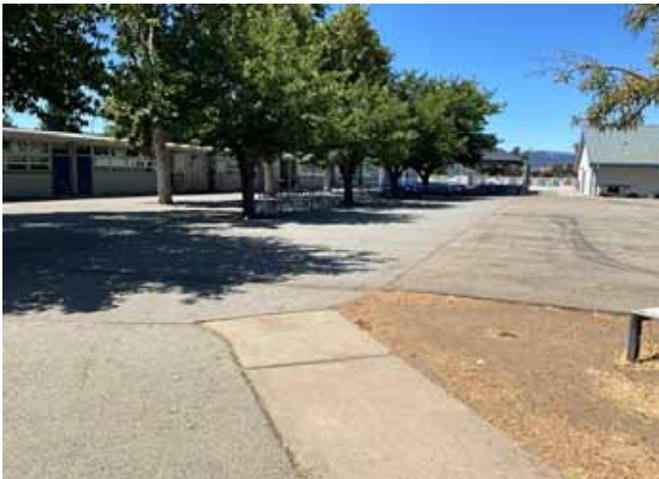
3 – SIDEWALKS

Sidewalk in Poor condition.

Asphalt path is uneven and deteriorated, creating trip hazers for students; replacement is recommended. -
AssetCALC ID: 9629975

Uniformat Code: G2030
Recommendation: **Replace in 2026**

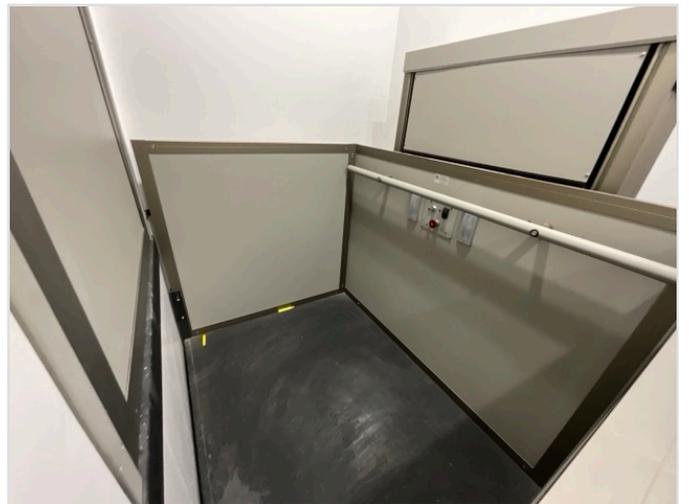
IN-CAB CONTROLS

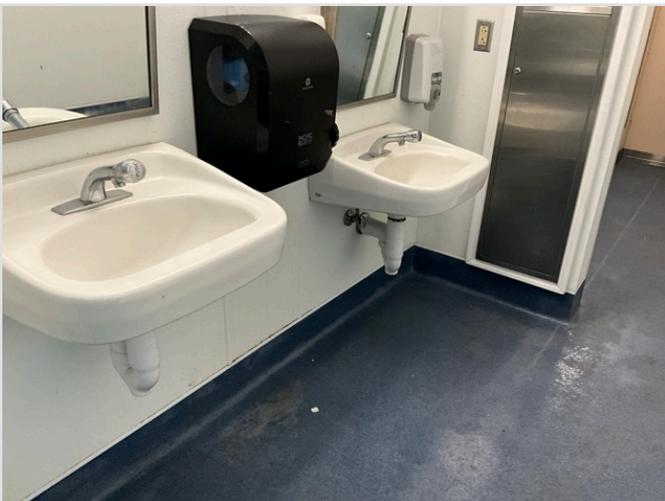
SINK, FAUCET HANDLES AND ACCESSORIES

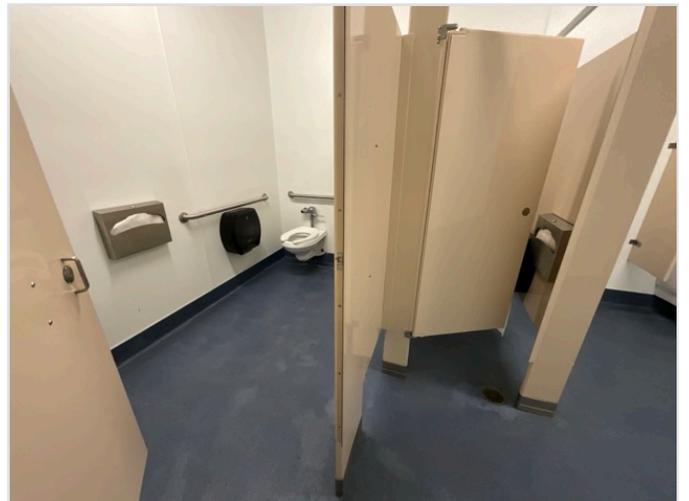
TOILET STALL OVERVIEW

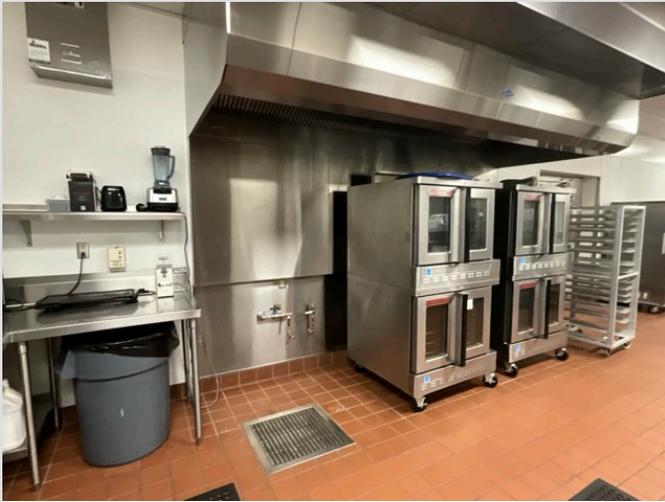
KITCHEN ACCESSORIES

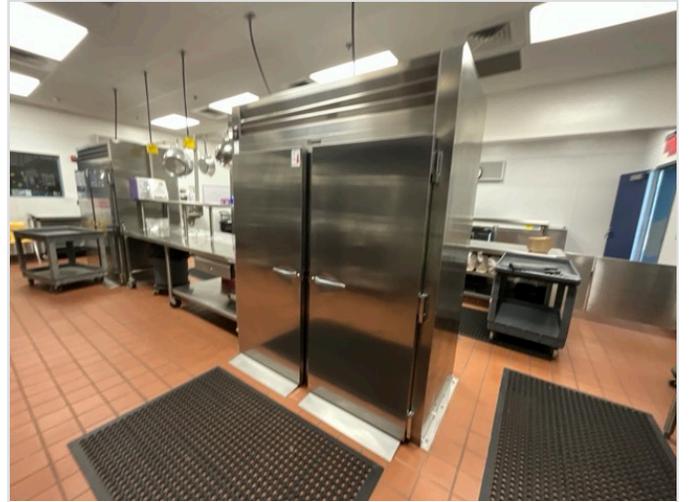
KITCHEN PATH OF TRAVEL

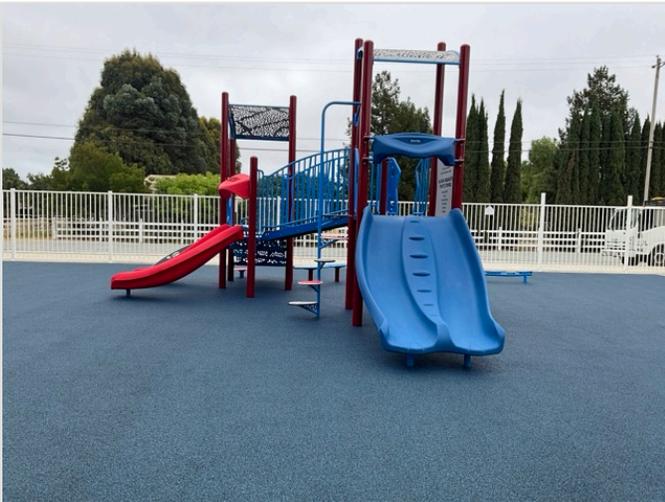
OVERVIEW OF PLAYGROUND

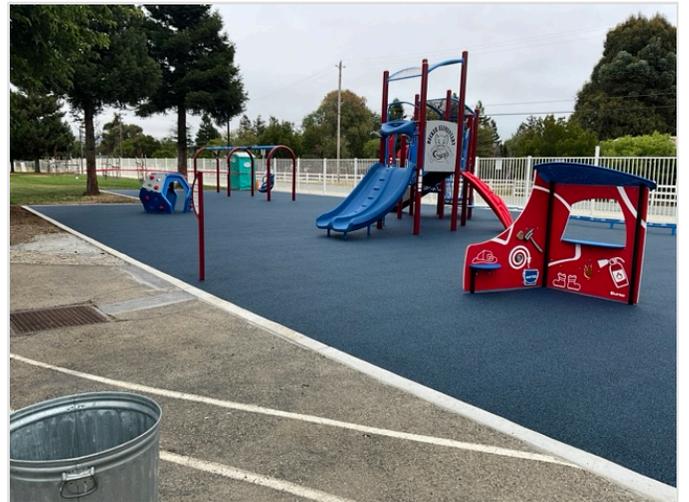
ACCESSIBLE ROUTE TO PLAYGROUND
