FACILITY CONDITION ASSESSMENT

Gilroy Unified School District
7810 Arroyo Circle
Gilroy, CA 95020

Gilroy High School
750 West 10th Street
Gilroy, CA 95020

August 30, 2025

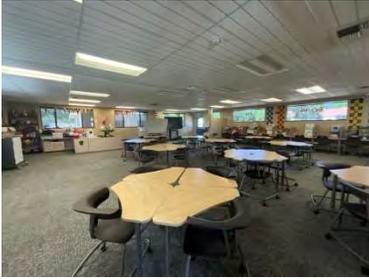
Fire Suppression System

Full System Install/Retrofit, Medium Density/Complexity
Building A1
Throughout Building

The building lacks a fire suppression system and the school is likely "grandfathered" based on code at the time of original construction. A comprehensive building renovation would likely trigger full compliance to current codes, and a budgetary cost for a full fire suppression retrofit is included in the initial five-year plan. - AssetCALC ID: 9633525

Uniformat Code: D4010
Recommendation: **Renovate in 2029**

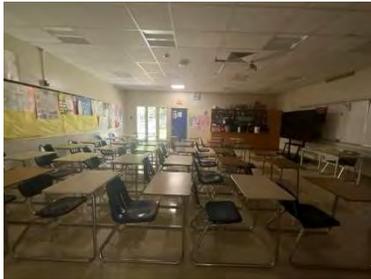
Fire Suppression System

Full System Install/Retrofit, Medium Density/Complexity
Building B
Throughout Building

The building lacks a fire suppression system and the school is likely "grandfathered" based on code at the time of original construction. A comprehensive building renovation would likely trigger full compliance to current codes, and a budgetary cost for a full fire suppression retrofit is included in the initial five-year plan. - AssetCALC ID: 9633648

Uniformat Code: D4010
Recommendation: **Renovate in 2029**

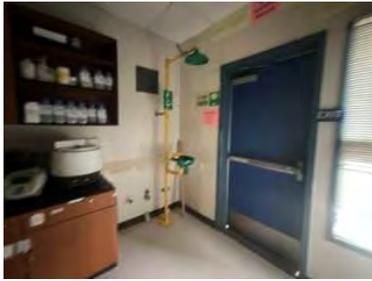
Fire Suppression System

Full System Install/Retrofit, Medium Density/Complexity
Building BE (North)
Throughout Building

The building lacks a fire suppression system and the school is likely "grandfathered" based on code at the time of original construction. A comprehensive building renovation would likely trigger full compliance to current codes, and a budgetary cost for a full fire suppression retrofit is included in the initial five-year plan. - AssetCALC ID: 9618211

Uniformat Code: D4010
Recommendation: **Renovate in 2029**

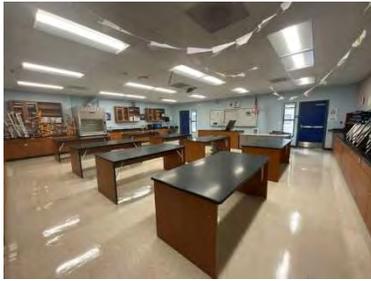
Fire Suppression System

Full System Install/Retrofit, Medium Density/Complexity
Building BE (South)
Throughout Building

The building lacks a fire suppression system and the school is likely "grandfathered" based on code at the time of original construction. A comprehensive building renovation would likely trigger full compliance to current codes, and a budgetary cost for a full fire suppression retrofit is included in the initial five-year plan. - AssetCALC ID: 9632165

Uniformat Code: D4010
Recommendation: **Renovate in 2029**

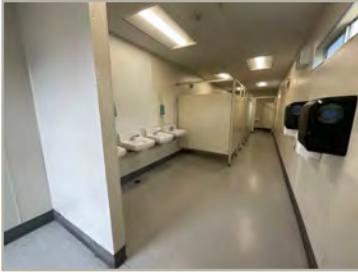
Fire Suppression System

Full System Install/Retrofit, Medium Density/Complexity
Building BR
Throughout Building

The building lacks a fire suppression system and the school is likely "grandfathered" based on code at the time of original construction. A comprehensive building renovation would likely trigger full compliance to current codes, and a budgetary cost for a full fire suppression retrofit is included in the initial five-year plan. - AssetCALC ID: 9618151

Recommendation: **Renovate in 2029**

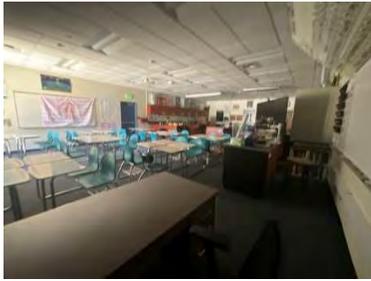
Fire Suppression System

Full System Install/Retrofit, Medium Density/Complexity
Building C
Throughout Building

The building lacks a fire suppression system and the school is likely "grandfathered" based on code at the time of original construction. A comprehensive building renovation would likely trigger full compliance to current codes, and a budgetary cost for a full fire suppression retrofit is included in the initial five-year plan. - AssetCALC ID: 9634145

Uniformat Code: D4010
Recommendation: **Renovate in 2029**

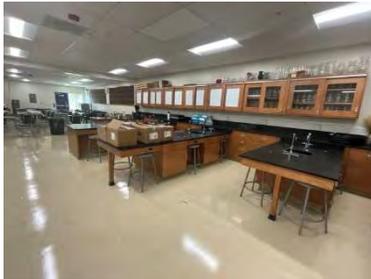
Fire Suppression System

Full System Install/Retrofit, Medium Density/Complexity
Building CE
Throughout Building

The building lacks a fire suppression system and the school is likely "grandfathered" based on code at the time of original construction. A comprehensive building renovation would likely trigger full compliance to current codes, and a budgetary cost for a full fire suppression retrofit is included in the initial five-year plan. - AssetCALC ID: 9635691

Uniformat Code: D4010
Recommendation: **Renovate in 2029**

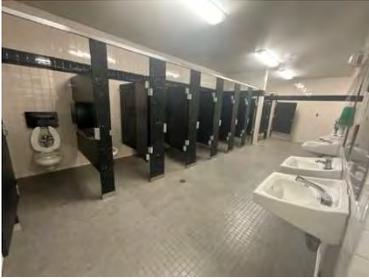
Fire Suppression System

Full System Install/Retrofit, Medium Density/Complexity
Building DR
Throughout Building

The building lacks a fire suppression system and the school is likely "grandfathered" based on code at the time of original construction. A comprehensive building renovation would likely trigger full compliance to current codes, and a budgetary cost for a full fire suppression retrofit is included in the initial five-year plan. - AssetCALC ID: 9617895

Uniformat Code: D4010
Recommendation: **Renovate in 2029**

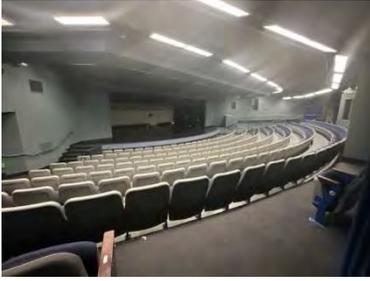
Fire Suppression System

Full System Install/Retrofit, Medium Density/Complexity
Building E1
Throughout Building

The building lacks a fire suppression system and the school is likely "grandfathered" based on code at the time of original construction. A comprehensive building renovation would likely trigger full compliance to current codes, and a budgetary cost for a full fire suppression retrofit is included in the initial five-year plan. - AssetCALC ID: 9637816

Uniformat Code: D4010
Recommendation: **Renovate in 2029**

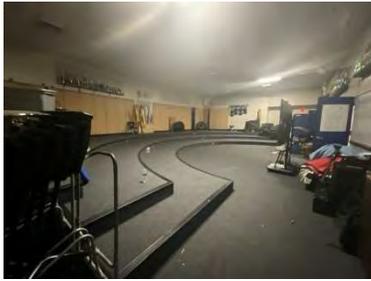
Fire Suppression System

Full System Install/Retrofit, Medium Density/Complexity
Building E2
Throughout Building

The building lacks a fire suppression system and the school is likely "grandfathered" based on code at the time of original construction. A comprehensive building renovation would likely trigger full compliance to current codes, and a budgetary cost for a full fire suppression retrofit is included in the initial five-year plan. - AssetCALC ID: 9617921

Uniformat Code: D4010
Recommendation: **Renovate in 2029**

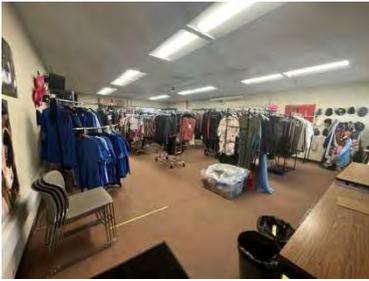
Fire Suppression System

Full System Install/Retrofit, Medium Density/Complexity
Building M14
Throughout Building

The building lacks a fire suppression system and the school is likely "grandfathered" based on code at the time of original construction. A comprehensive building renovation would likely trigger full compliance to current codes, and a budgetary cost for a full fire suppression retrofit is included in the initial five-year plan. - AssetCALC ID: 9642997

Uniformat Code: D4010
Recommendation: **Renovate in 2029**

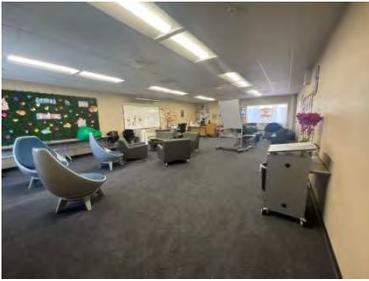
Fire Suppression System

Full System Install/Retrofit, Medium Density/Complexity
Building M15 & M16
Throughout Building

The building lacks a fire suppression system and the school is likely "grandfathered" based on code at the time of original construction. A comprehensive building renovation would likely trigger full compliance to current codes, and a budgetary cost for a full fire suppression retrofit is included in the initial five-year plan. - AssetCALC ID: 9642876

Uniformat Code: D4010
Recommendation: **Renovate in 2029**

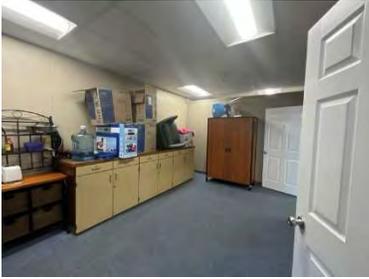
Fire Suppression System

Full System Install/Retrofit, Medium Density/Complexity
Building M7
Throughout Building

The building lacks a fire suppression system and the school is likely "grandfathered" based on code at the time of original construction. A comprehensive building renovation would likely trigger full compliance to current codes, and a budgetary cost for a full fire suppression retrofit is included in the initial five-year plan. - AssetCALC ID: 9642833

Uniformat Code: D4010
Recommendation: **Renovate in 2029**

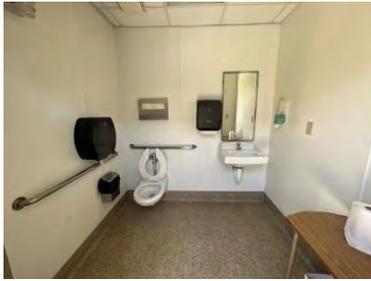
Fire Suppression System

Full System Install/Retrofit, Medium Density/Complexity
Building MR
Throughout Building

The building lacks a fire suppression system and the school is likely "grandfathered" based on code at the time of original construction. A comprehensive building renovation would likely trigger full compliance to current codes, and a budgetary cost for a full fire suppression retrofit is included in the initial five-year plan. - AssetCALC ID: 9642046

Uniformat Code: D4010
Recommendation: **Renovate in 2029**

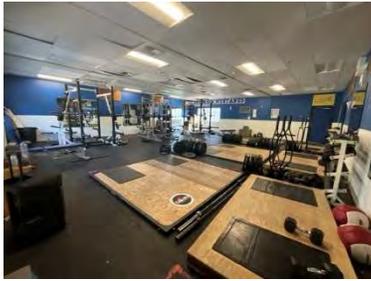
Fire Suppression System

Full System Install/Retrofit, Medium Density/Complexity
Building P (10-13 &19)
Throughout Building

The building lacks a fire suppression system and the school is likely "grandfathered" based on code at the time of original construction. A comprehensive building renovation would likely trigger full compliance to current codes, and a budgetary cost for a full fire suppression retrofit is included in the initial five-year plan. - AssetCALC ID: 9638655

Uniformat Code: D4010
Recommendation: **Renovate in 2029**

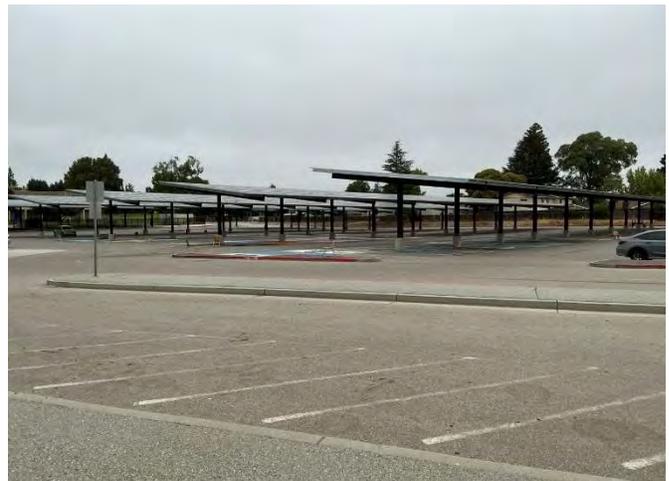
6 – PARKING AREA

Parking Lots in Poor condition.

Asphalt in parking area is deteriorated and requires repair. - AssetCALC ID: 9620425

Parking asphalt after repair requires sealing and restriping - AssetCALC ID: 9620426

Uniformat Code: G2020
Recommendation: **Mill & Overlay in 2026**

Uniformat Code: G2020
Recommendation: **Seal & Stripe in 2026**
