FACILITY CONDITION ASSESSMENT

Gilroy Unified School District

Glen View Elementary School

July 28, 2025

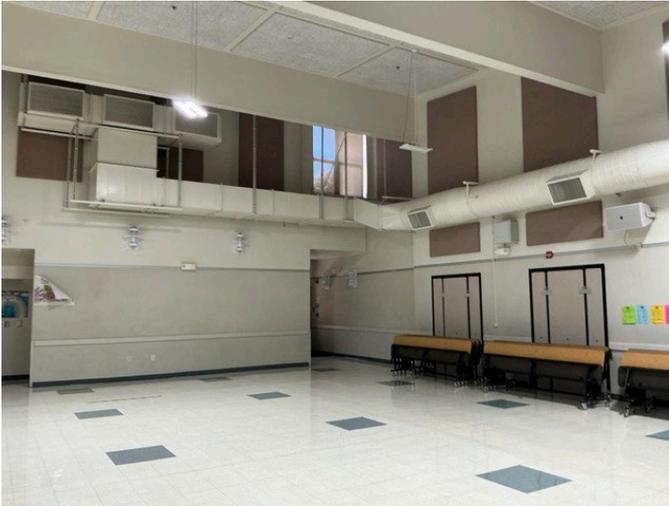
7 - INTERIOR VIEW OF MPR

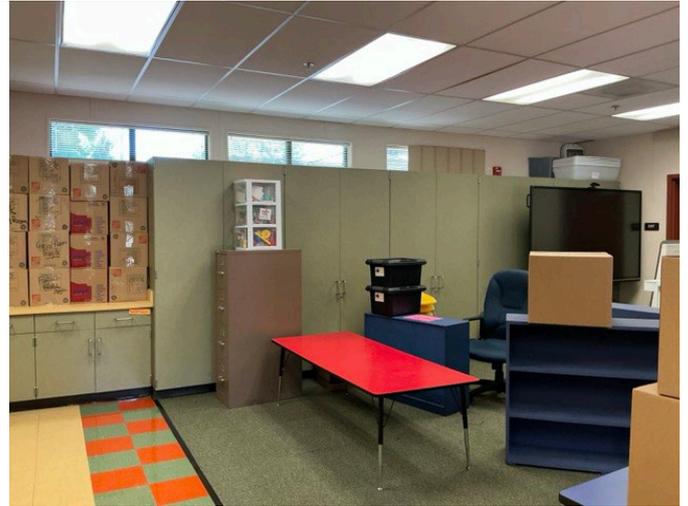
8 - INTERIOR VIEW OF CLASSROOM

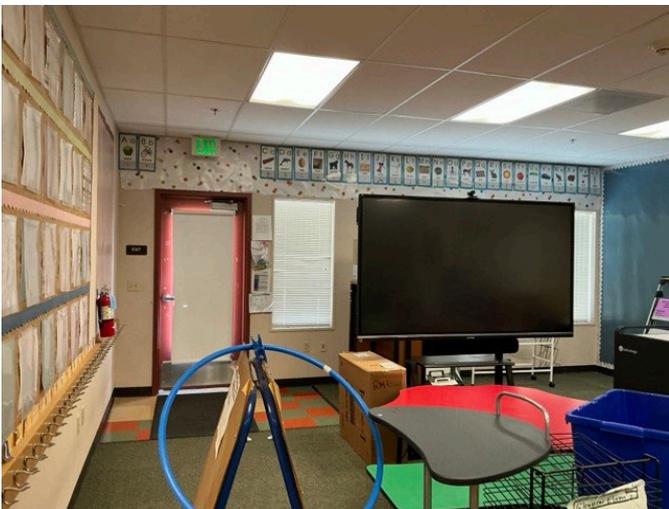
9 - INTERIOR VIEW OF CLASSROOM

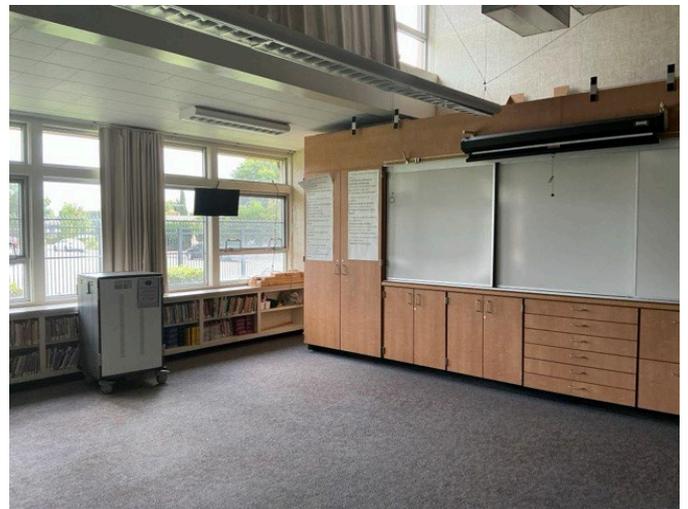
10 - INTERIOR VIEW OF CLASSROOM

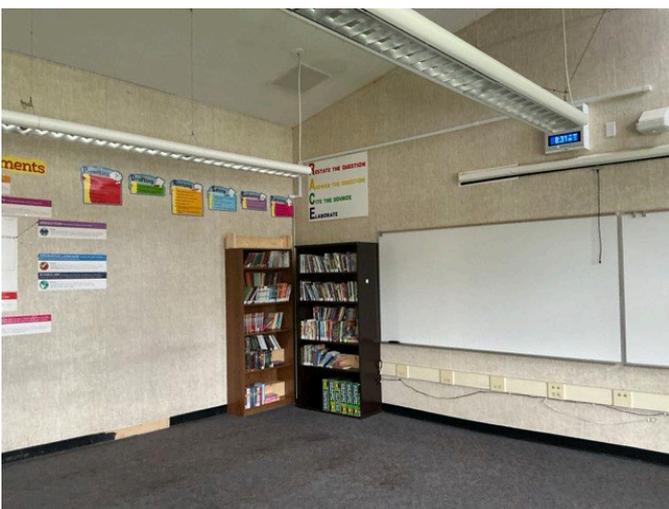
11 - INTERIOR VIEW OF CLASSROOM

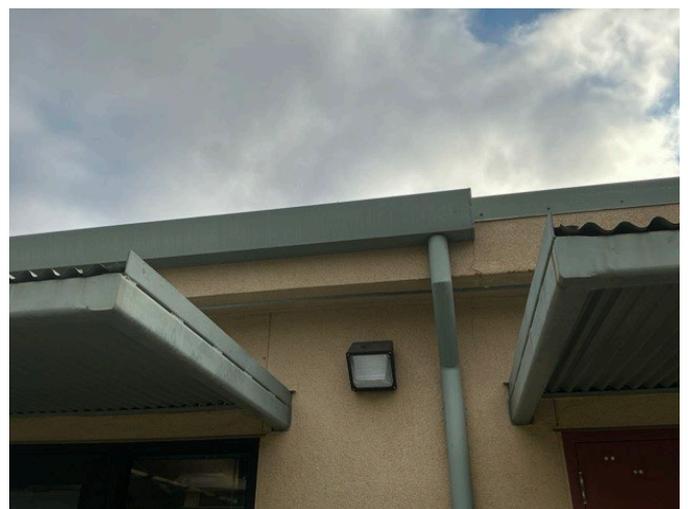
12 - ASPHALT ROOFING

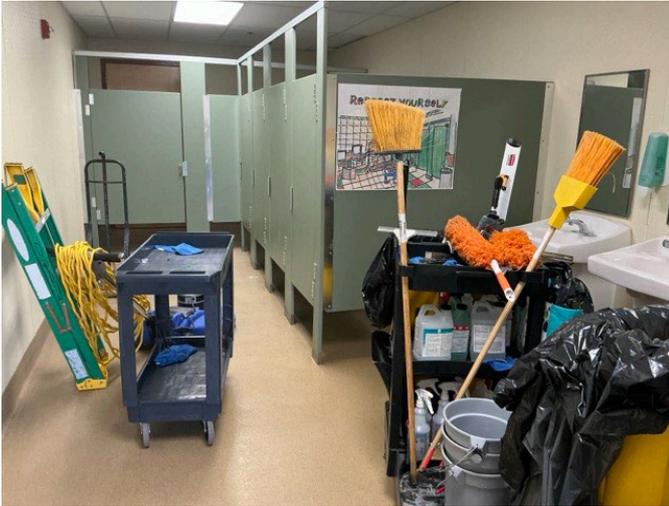
13 - RESTROOM OVERVIEW

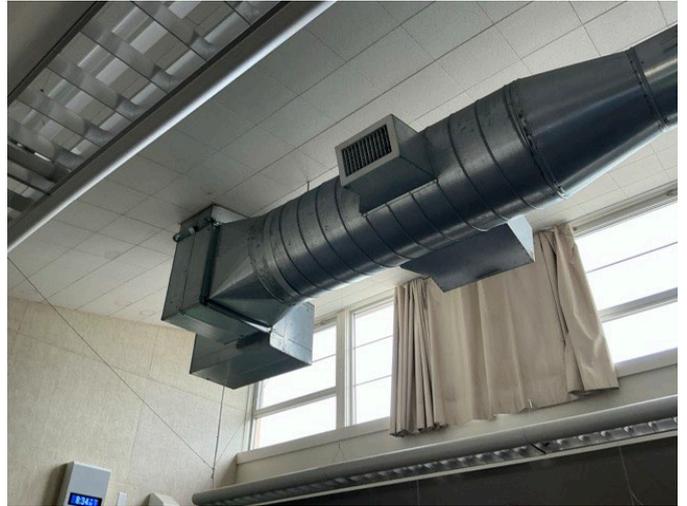
14 - HVAC SYSTEM

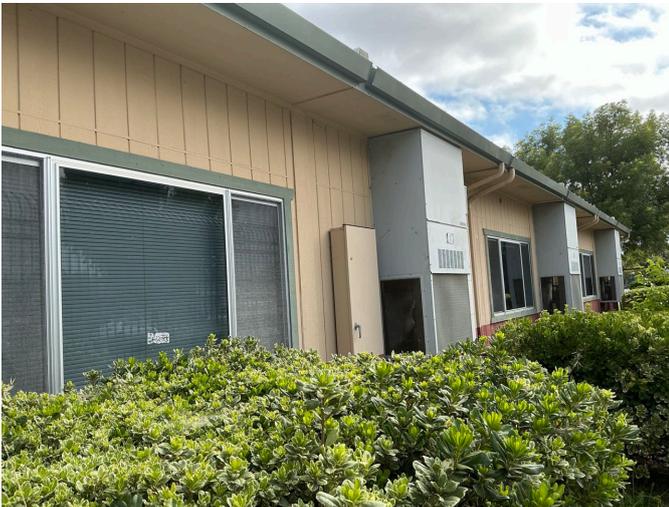
15 - REAR ELEVATION

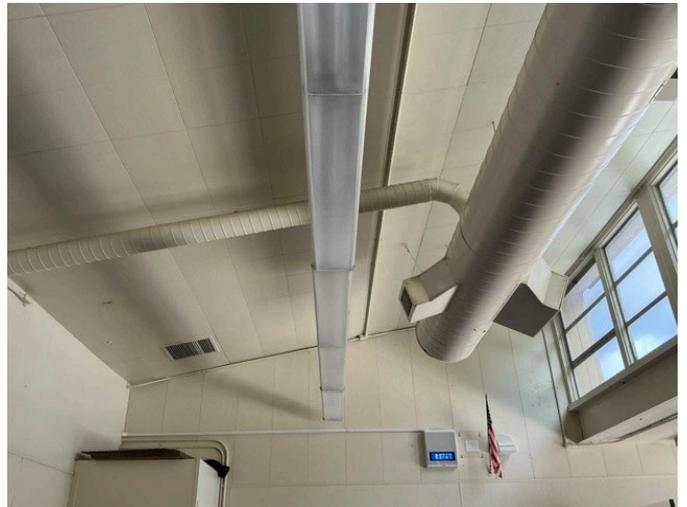
16 - INTERIOR LIGHTING SYSTEM

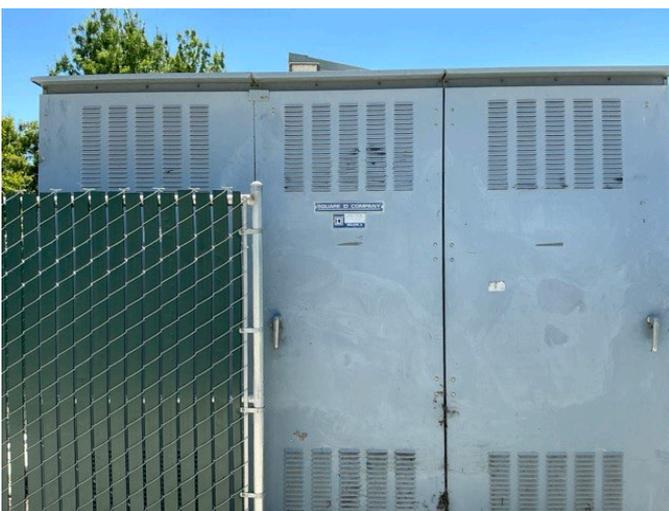
17 - SWITCHBOARD

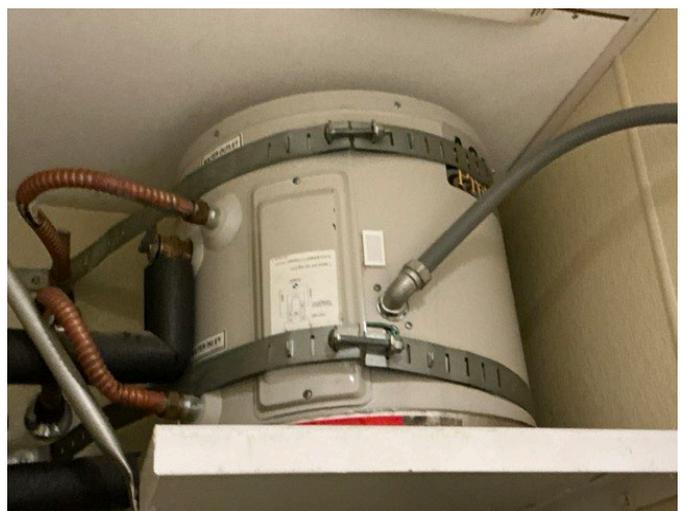
18 - WATER HEATER

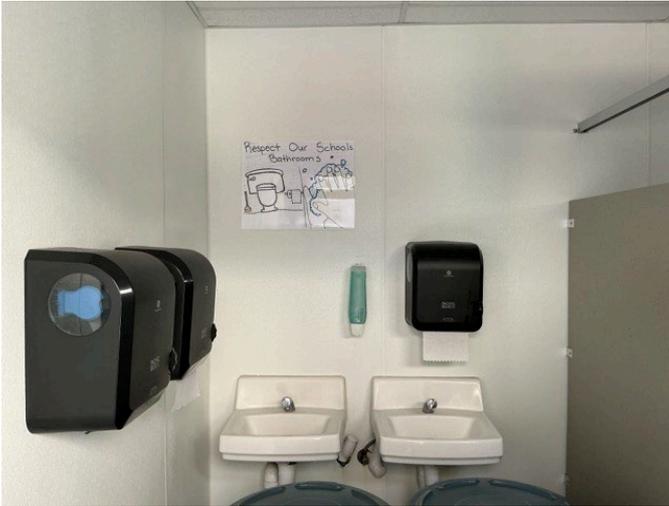
19 - PLUMBING SYSTEM

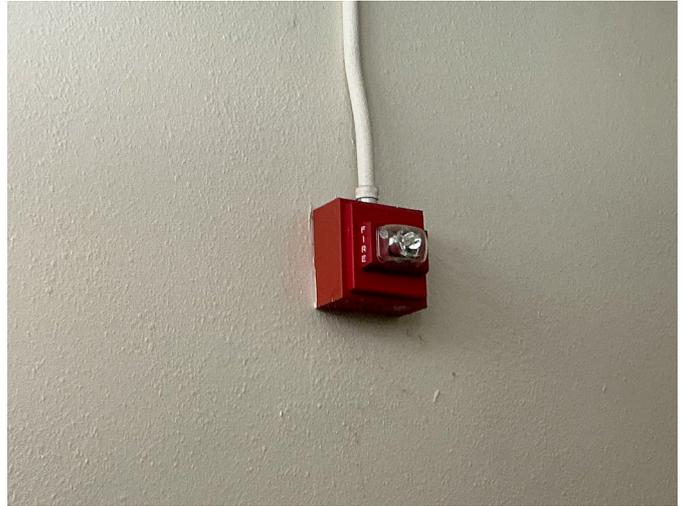
20 - FIRE ALARM SYSTEM

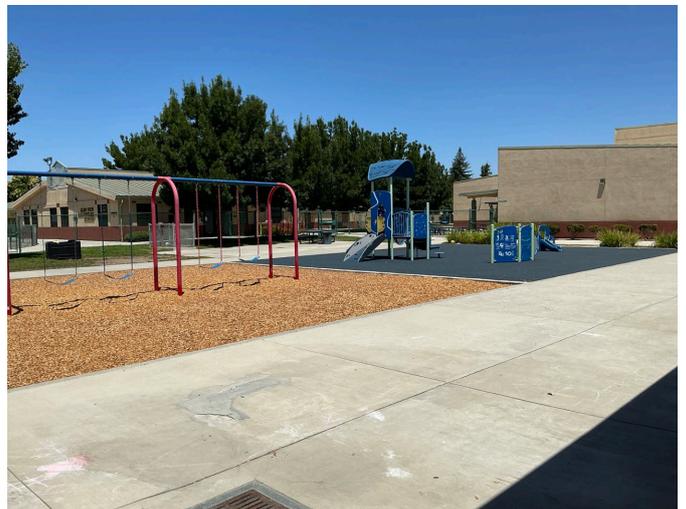
22 - VIEW OF PLAYGROUND

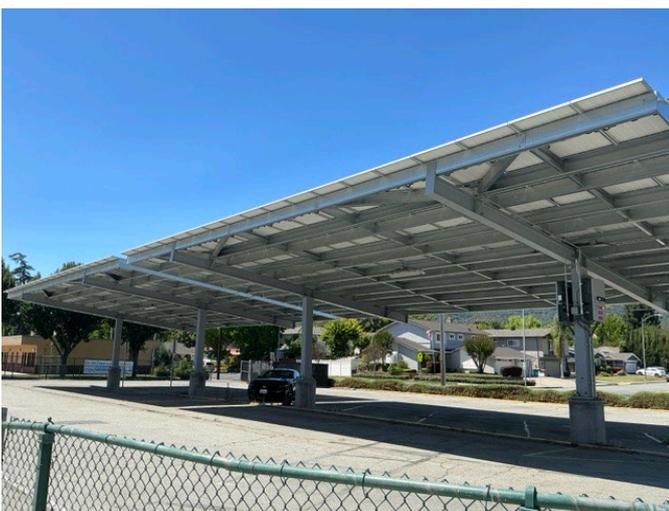
23 - SOLAR POWER ON CARPORT

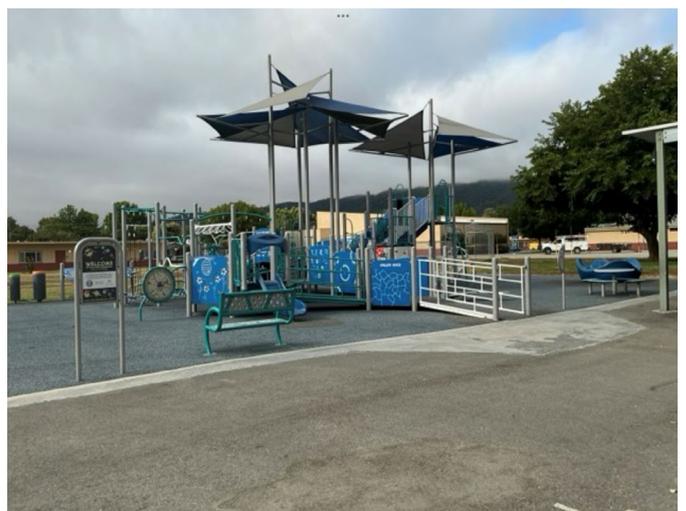
24 - PLAY STRUCTURE

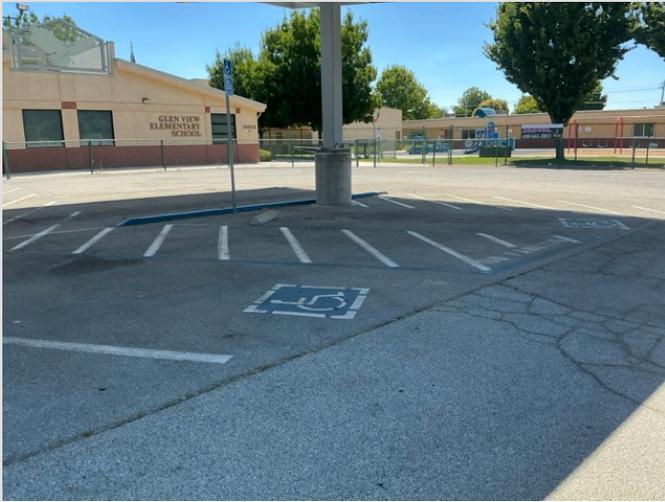
OVERVIEW OF ACCESSIBLE PARKING AREA

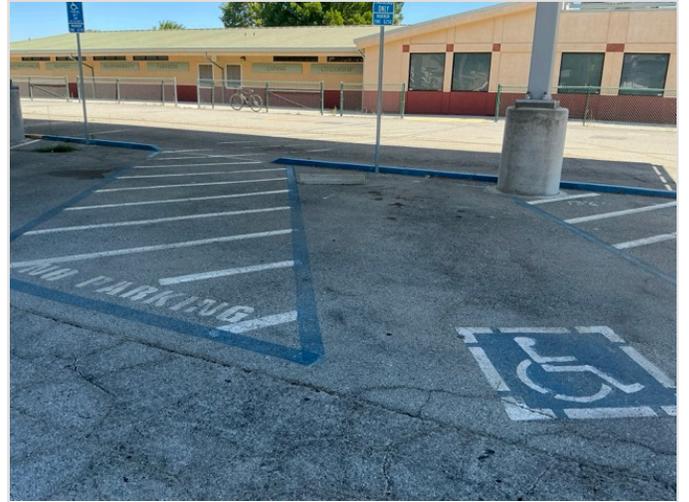
CLOSE-UP OF STALL

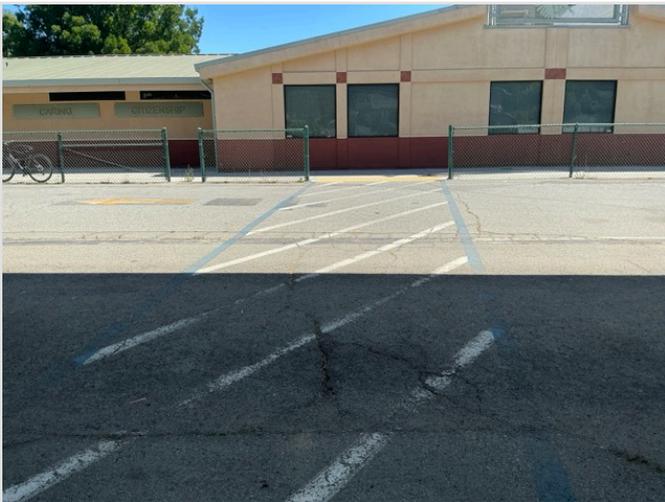
ACCESSIBLE PATH

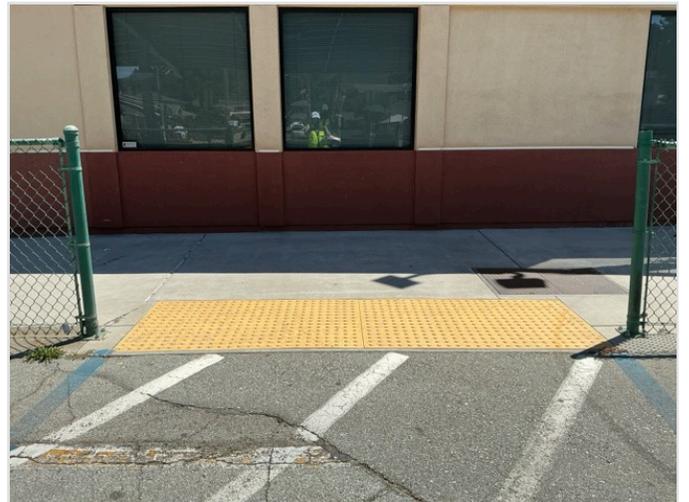
CURB CUT

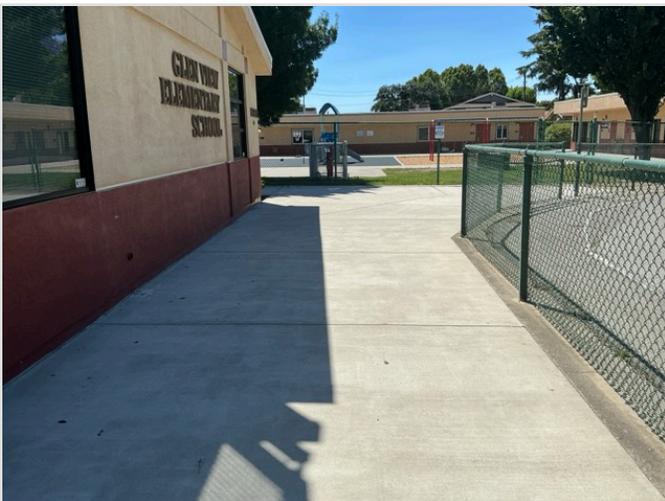
ACCESSIBLE ENTRANCE

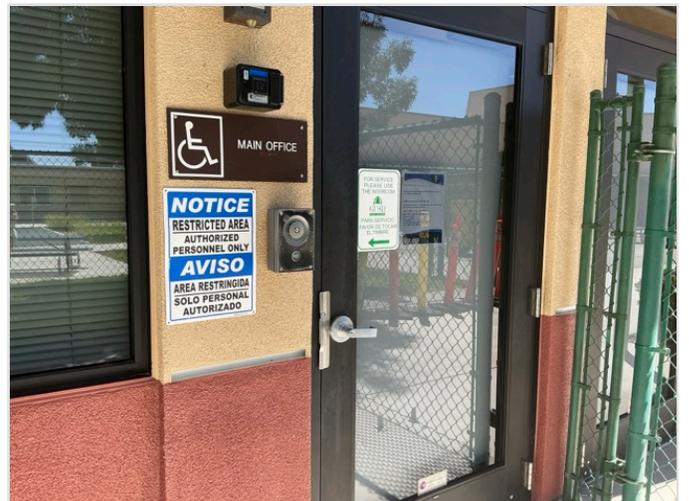
DOOR HARDWARE

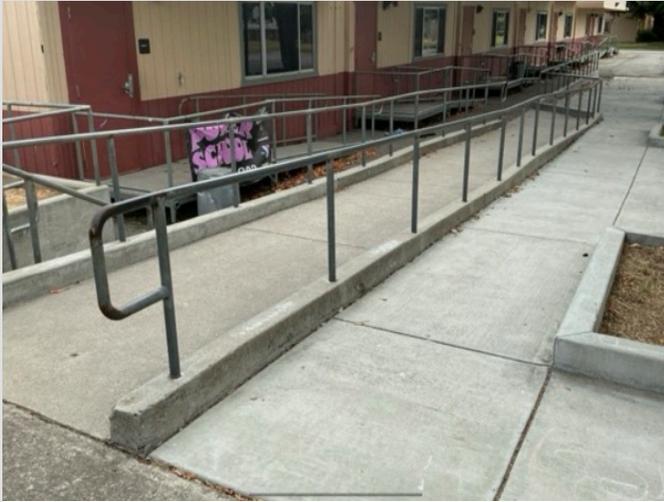
ACCESSIBLE INTERIOR RAMP

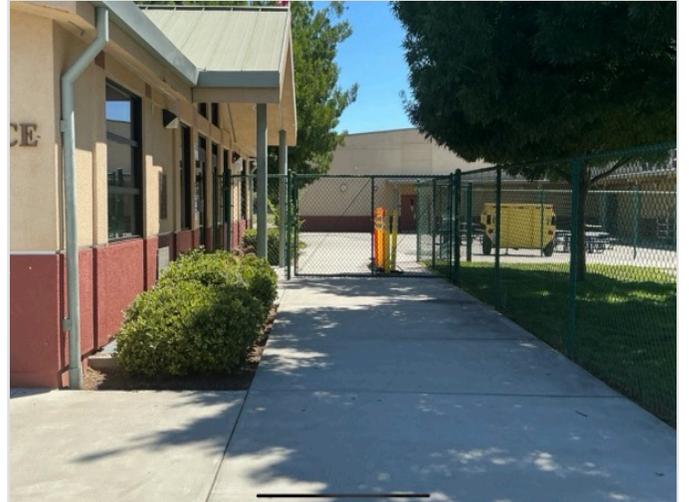
ACCESSIBLE INTERIOR PATH

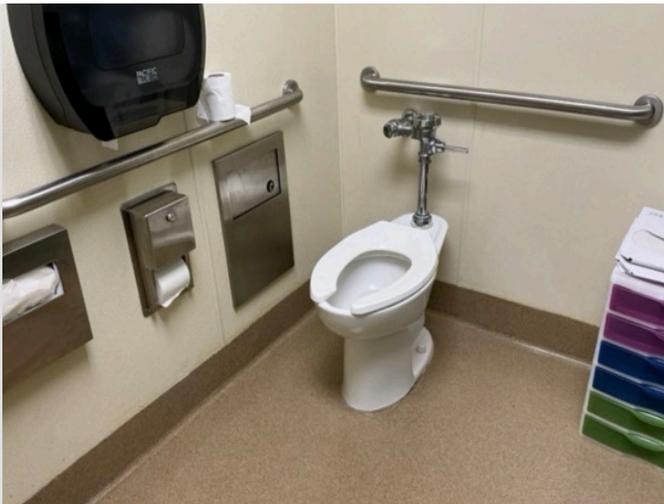
TOILET STALL OVERVIEW

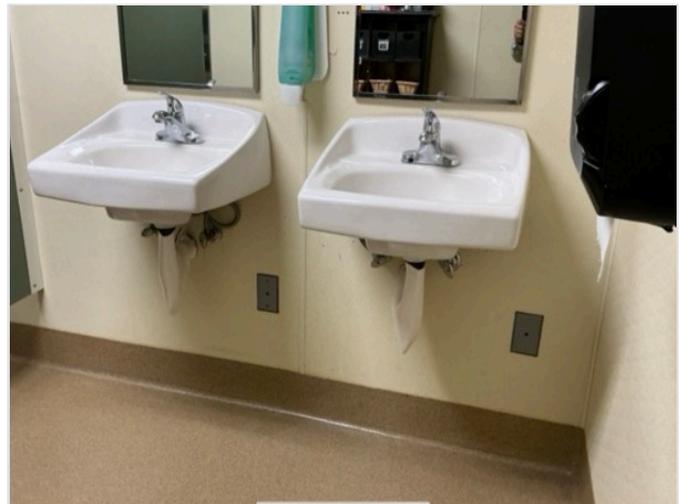
SINK, FAUCET HANDLES, AND ACCESSORIES

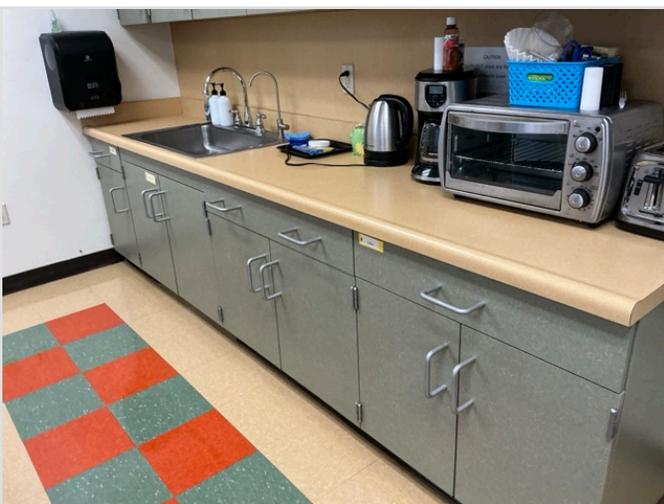
KITCHEN OVERVIEW

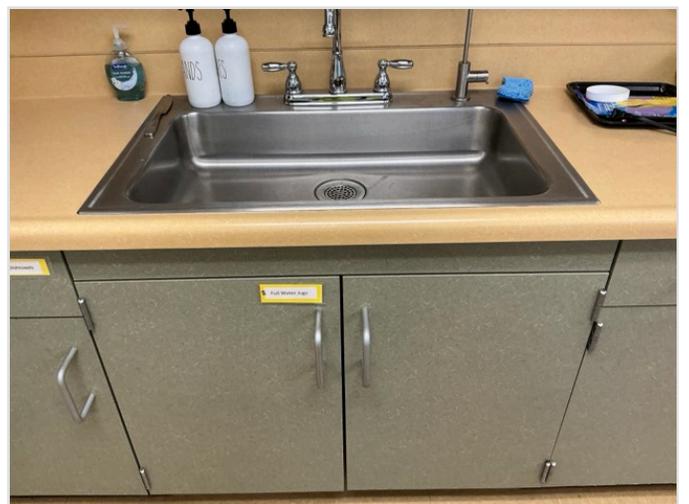
KITCHEN CABINETS

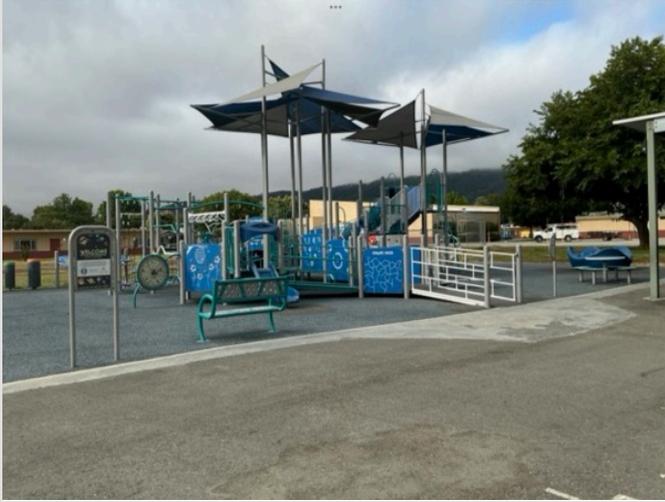
ACCESSIBLE ROUTE TO PLAYGROUND

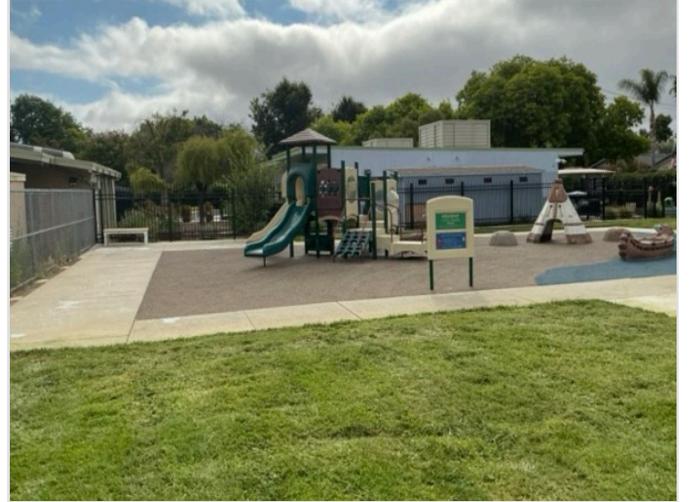
OVERVIEW OF PLAYGROUND
