# FACILITY CONDITION ASSESSMENT

**Gilroy Unified School District**  
7810 Arroyo Circle  
Gilroy, CA 95020

Christopher High School  
850 Day Road  
Gilroy, CA 95020

*Bureau Veritas*  
6021 University Boulevard, Suite 200  
Ellicott City, MD 21043  
800.733.0660  
[www.bvna.com](http://www.bvna.com)

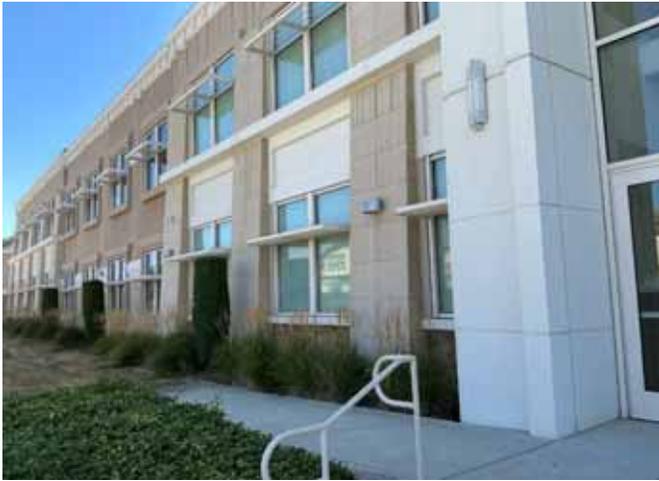
1 – BUILDING E

Roof has leaks and requires attention. - AssetCALC ID: 9590631

Roof for Building E has leaks. Recommendations are to perform moisture scan to decide between coating or replacement. - AssetCALC ID: 9590661

Uniformat Code: P2030  
Recommendation: **Evaluate/Report in 2025**

Uniformat Code: B3010  
Recommendation: **Replace in 2027**

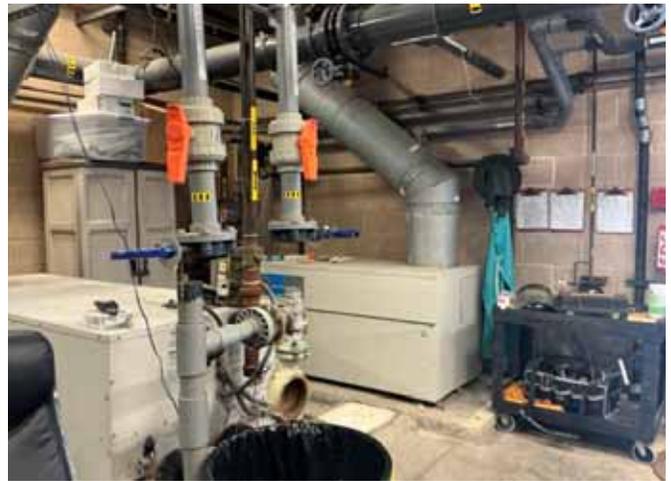
4 – POOL HEATERS

### **Pool Equipment in Poor condition.**

Heater is in poor condition. - AssetCALC ID: 9589407

Uniformat Code: F1050  
Recommendation: **Replace in 2027**

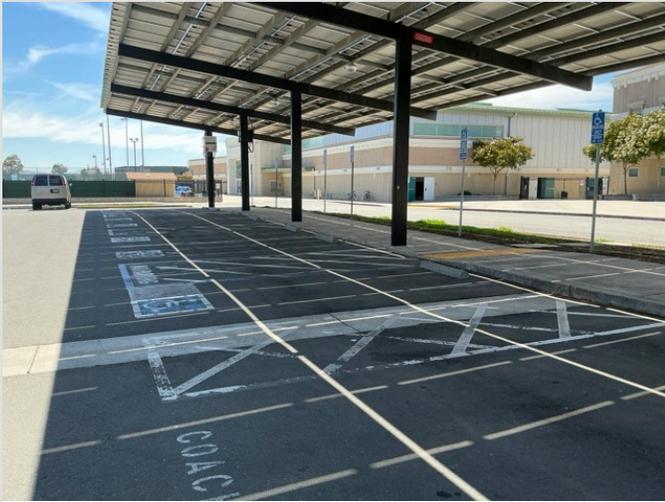
OVERVIEW OF ACCESSIBLE PARKING AREA

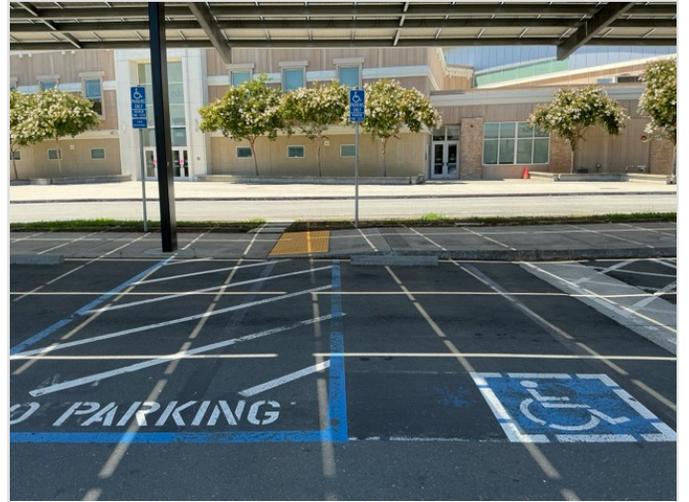
CLOSE-UP OF STALL

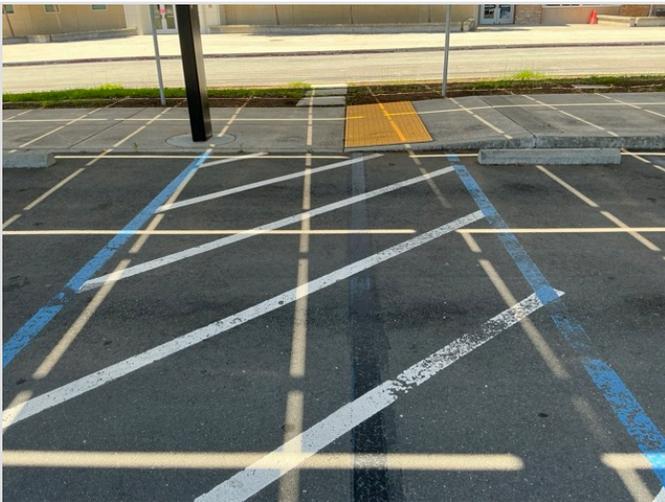
ACCESSIBLE PATH

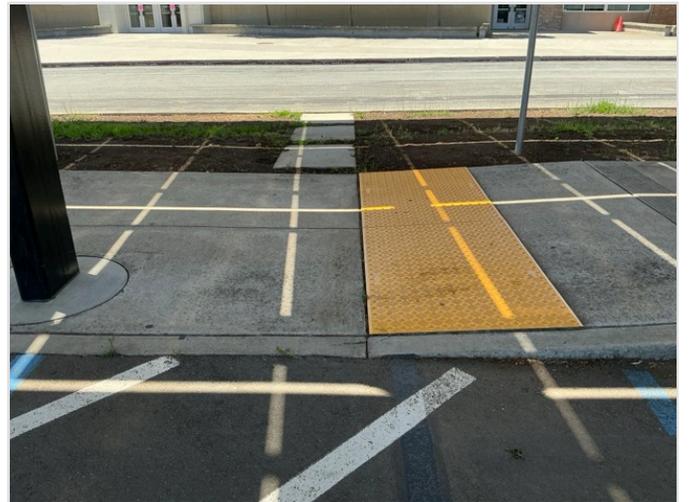
CURB CUT

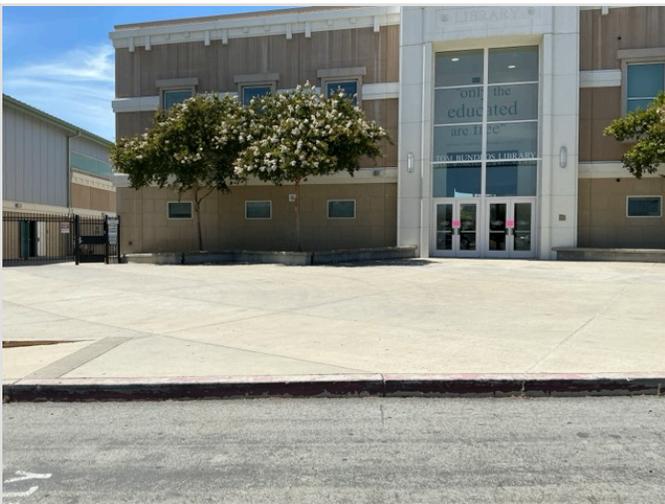
ACCESSIBLE ENTRANCE

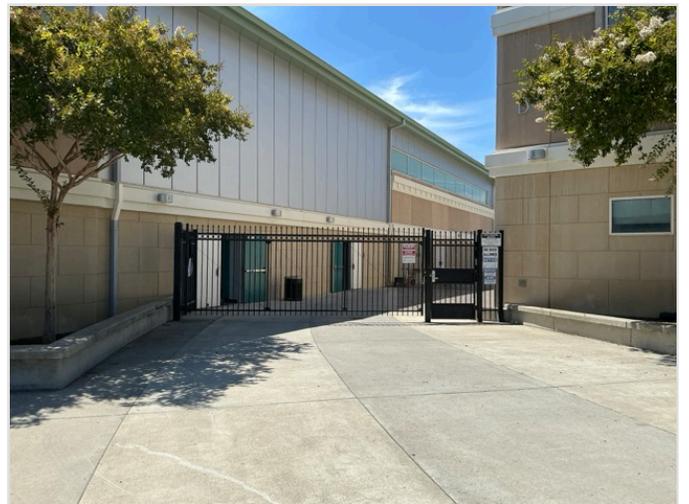
ADDITIONAL ENTRANCE

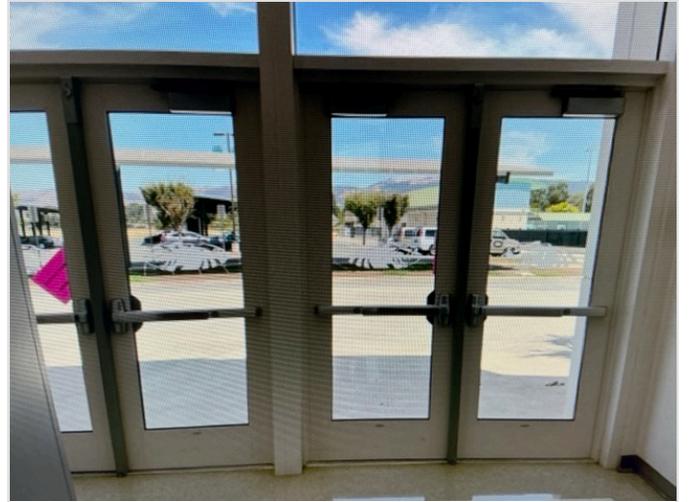
DOOR HARDWARE

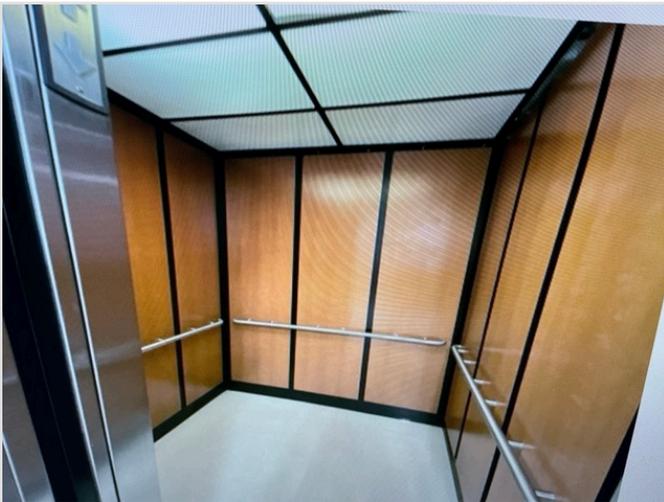
LOBBY LOOKING AT CABS

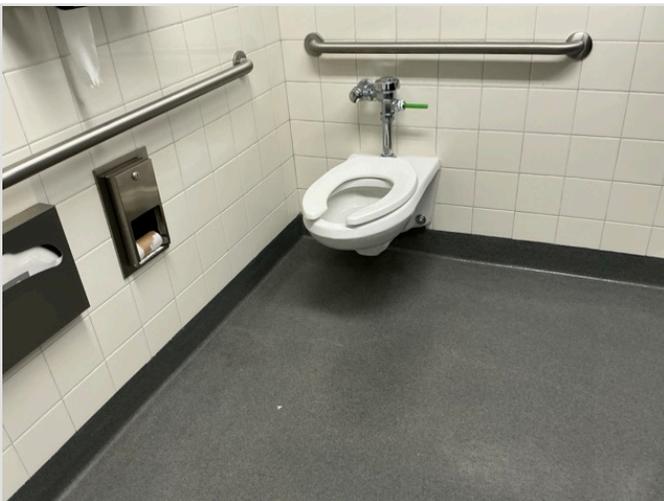
TOILET STALL OVERVIEW

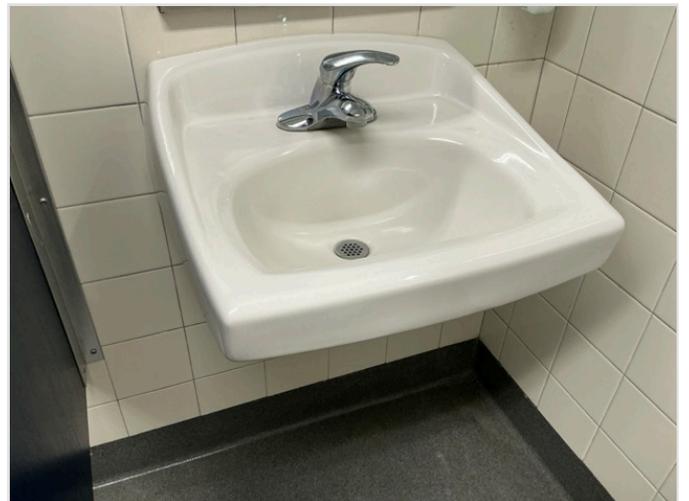
SINK, FAUCET HANDLES AND ACCESSORIES

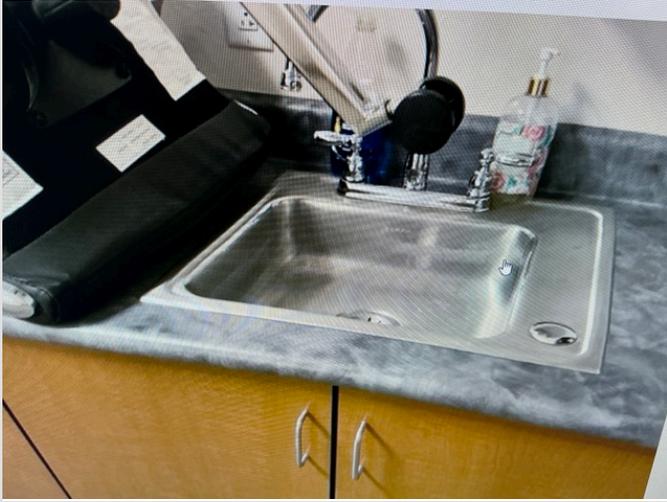
KITCHEN CABINETS

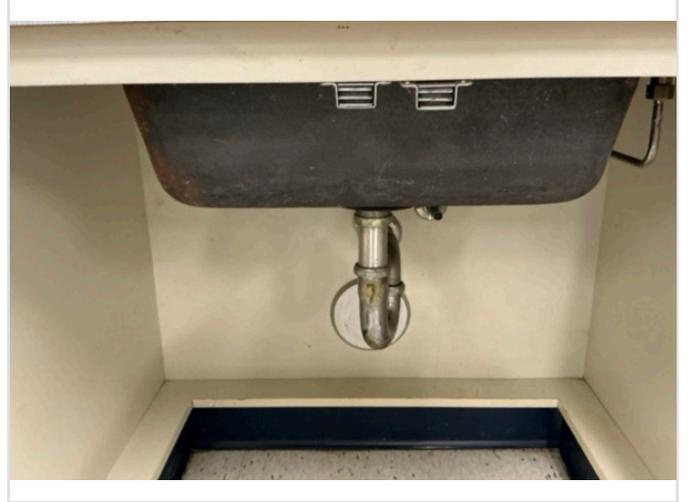
SINK CLEARANCE
